### Massachusetts Water Resources Authority

#### **MWRA Board of Directors**

## Shaft 5A Pipe Break

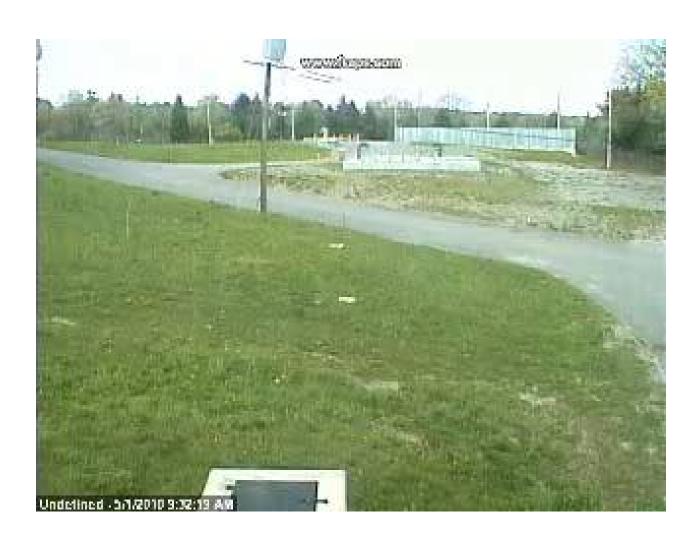
### **Surveillance Camera Captures Leak**

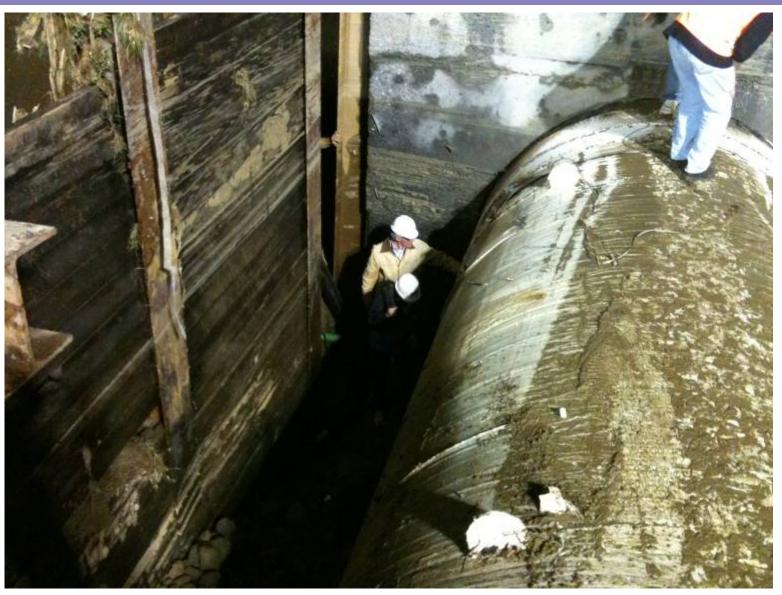
# Probing

- As soon as the site (hole) was dewatered, MWRA Staff and Consultants and Contractor started:
  - Visual Inspection
  - Excavation below Pipe
    - People under pipe doing inspection
    - Vactor removal of loose material under pipe
    - Probing into soil under pipe by geotechnical consultant
  - State Police divers in Charles River looking for old collar
  - Ground penetrating radar and electromagnetic detectors to try locate old collar
  - Soil removal from River, with stockpiling on adjacent land to inspect for old collar or other information
  - Magnetic Metal Detectors
  - Metallurgical tests on any metal found
