**MWRA Board of Directors**

***Overview of Water Pipeline Maintenance  
Leak Repairs***

July 24, 2024

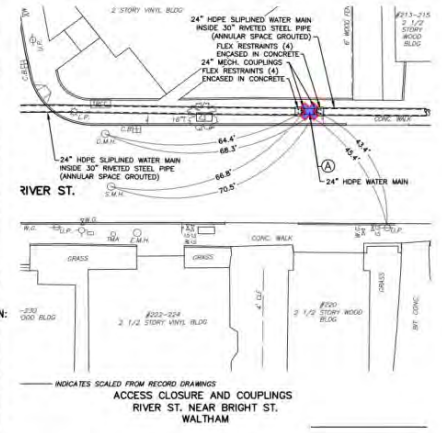
INDICATES SCALED FROM RECORD DRAWINGS  
ACCESS CLOSURE AND COUPLINGS  
RIVER ST. NEAR BRIGHT ST.  
WALTHAM

Remarks: Leak appears to be on mechanical couplings on Watertown Section WS-3B as shown on the Detail Records. Minimal to no sound is heard through leak detection devices in this area but water did come back chlorinated. The public Waltham water main service to this building is off Bright St.

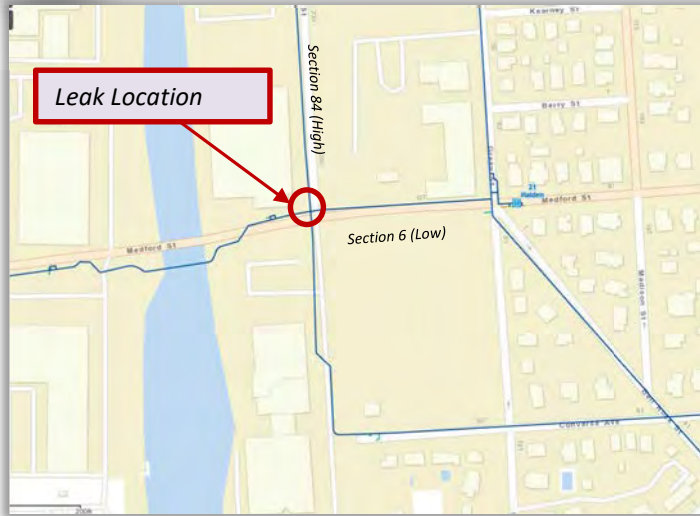
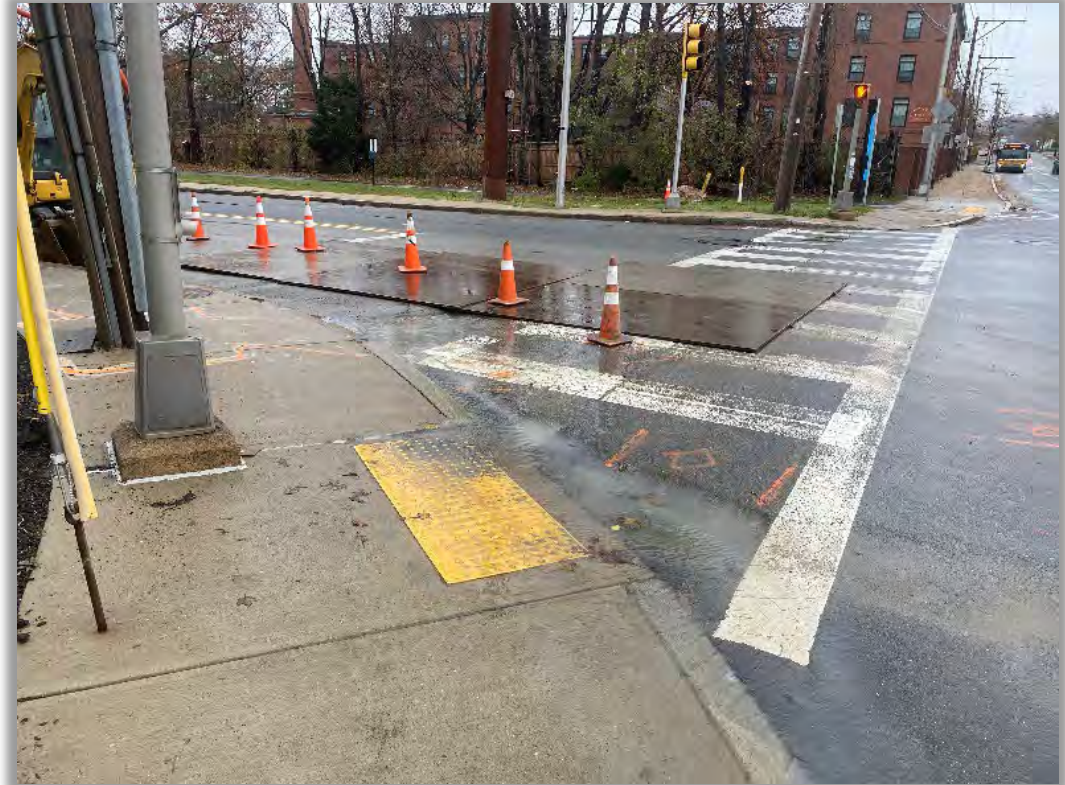
# Section 84 Leak

- Reported by City of Malden
- Confirmed by MWRA Leak Detection Crew
- Located on MWRA Section 84 pipeline

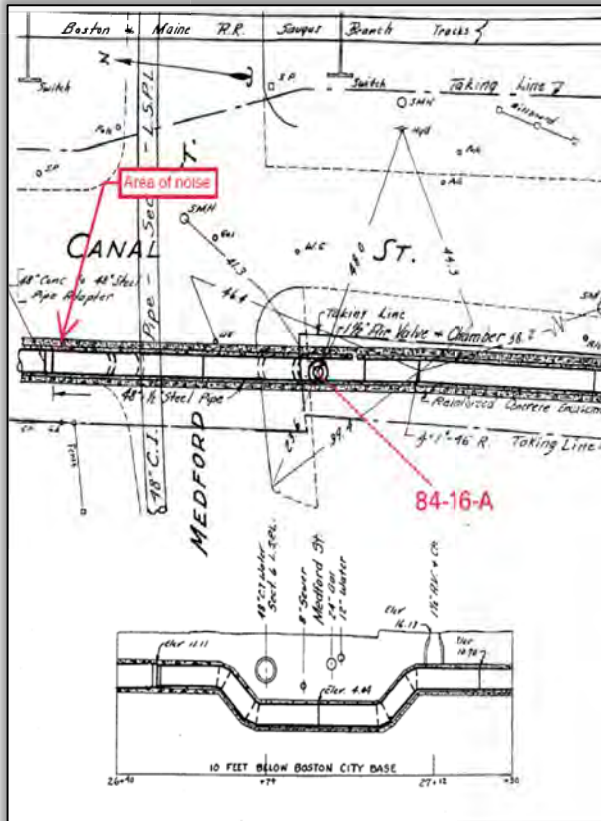
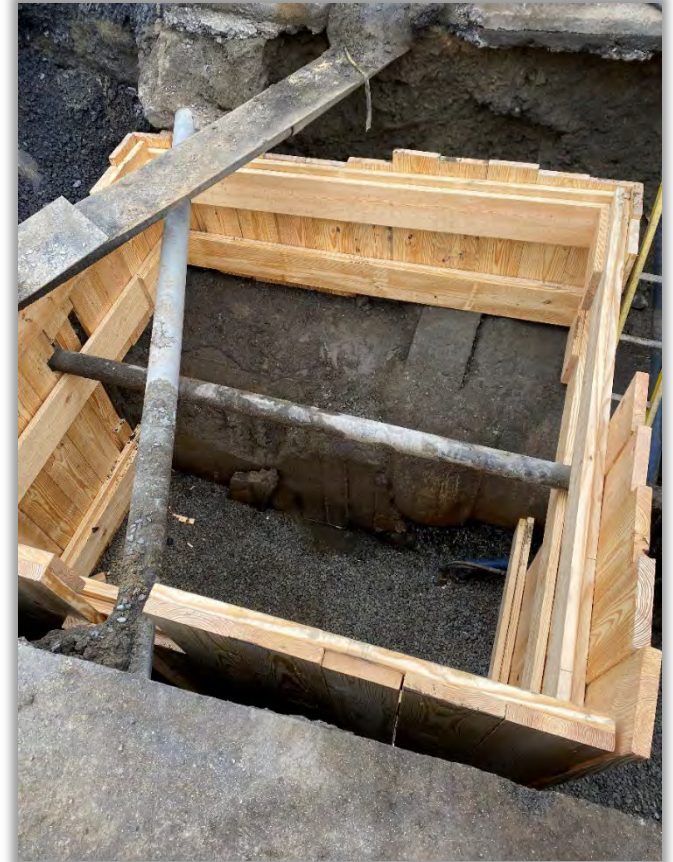
- Pipe transitions to concrete encased steel at intersection
- Leak suspected in steel section
- Difficult excavation

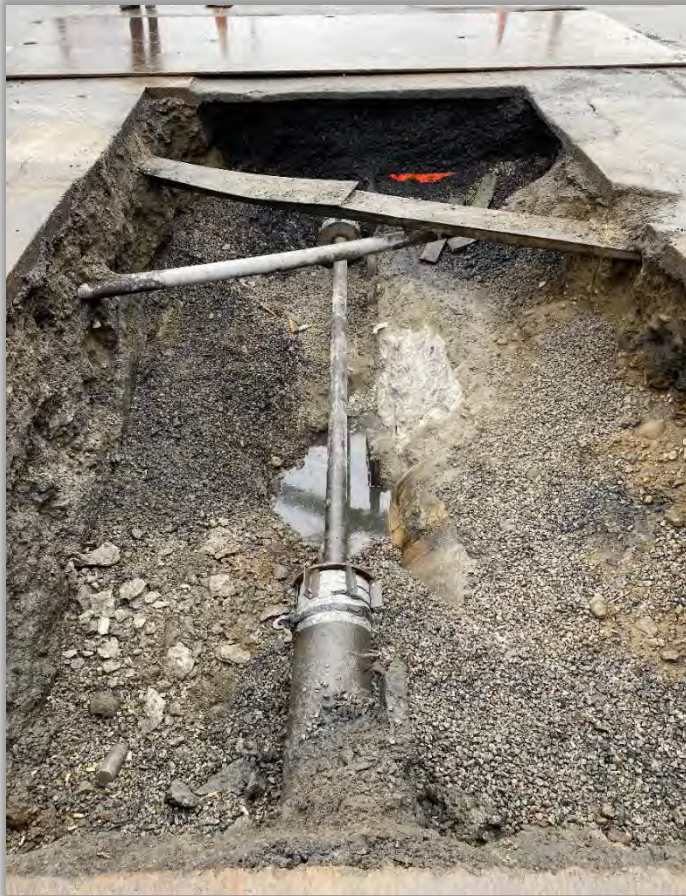
# Utility Conflicts

- City of Malden 12-inch water line conflict
- Main to be relocated
- Installed new valves and restraint

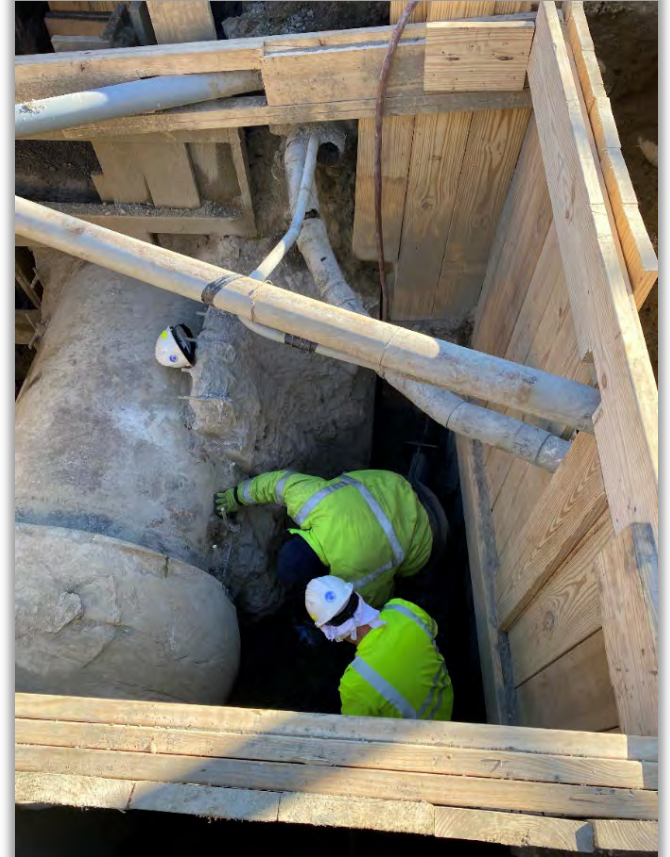
# Concrete Encasement

- Concrete encasement concealed leak
- Staff had to remove encasement on one side of pipe
- Very labor intensive

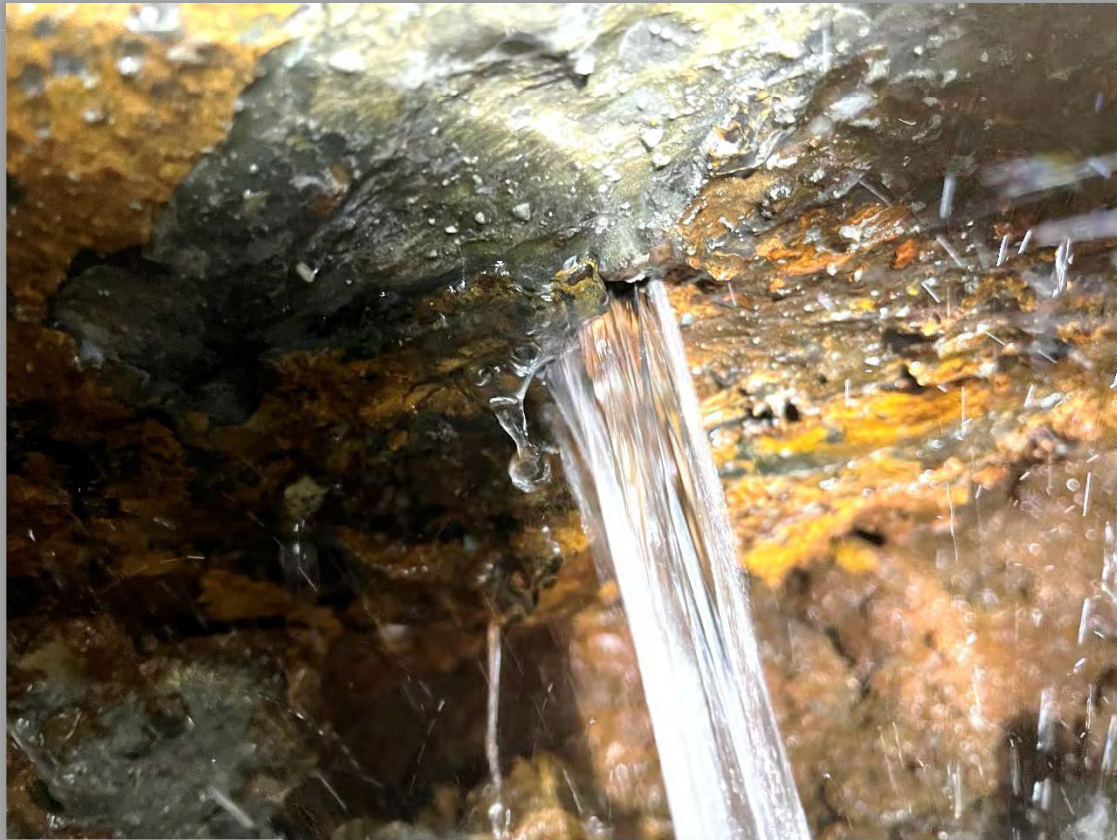
## Leak located

- Steel corroded on bottom of pipe
- Pipe severely pitted

- Thickness testing of steel pipe
- Recommended rolled steel welded repair
- Remove entire concrete encasement
