MWRA Board of Directors

***MWRA's Outfall Monitoring Overview
2014 Results***

October 14, 2015

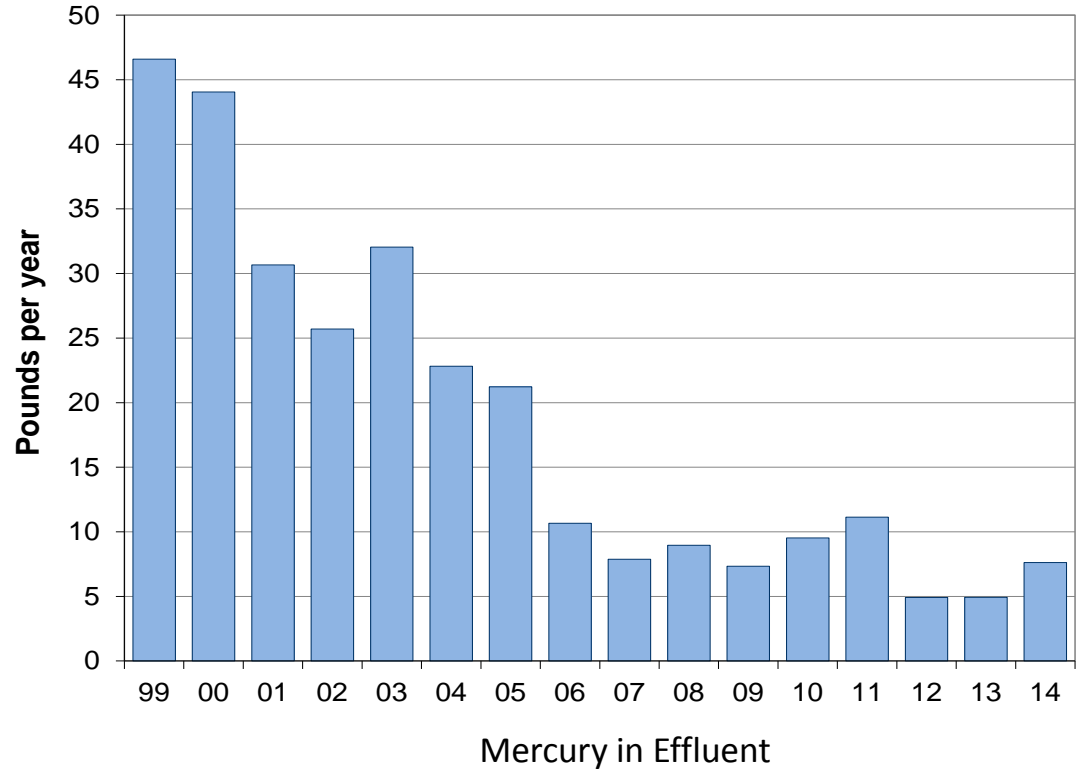
Contaminants in DITP effluent, 2014

- Metals remained low in 2014
 - <20% of discharge to Harbor in early 1990s.
 - Zinc has the highest load and is least toxic; has many sources.
 - Mercury has declined over last decade, < 8 pounds discharged in 2014.

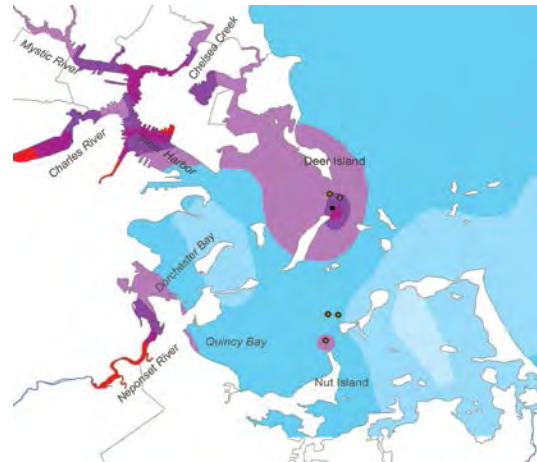
Prior to Boston Harbor projects (1989-1991)

Geometric mean (colonies/100 mL)
Sampled during rainfall
≥0.2 inches within 24 hours

Blue contours meet swimming standard, red-purple contours exceed swimming standard

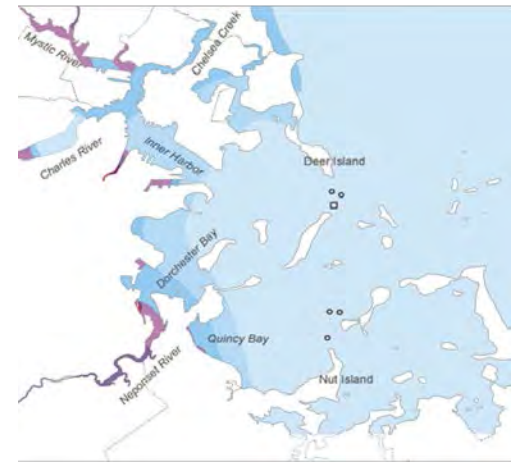
Most Boston Harbor projects complete (post-2007)

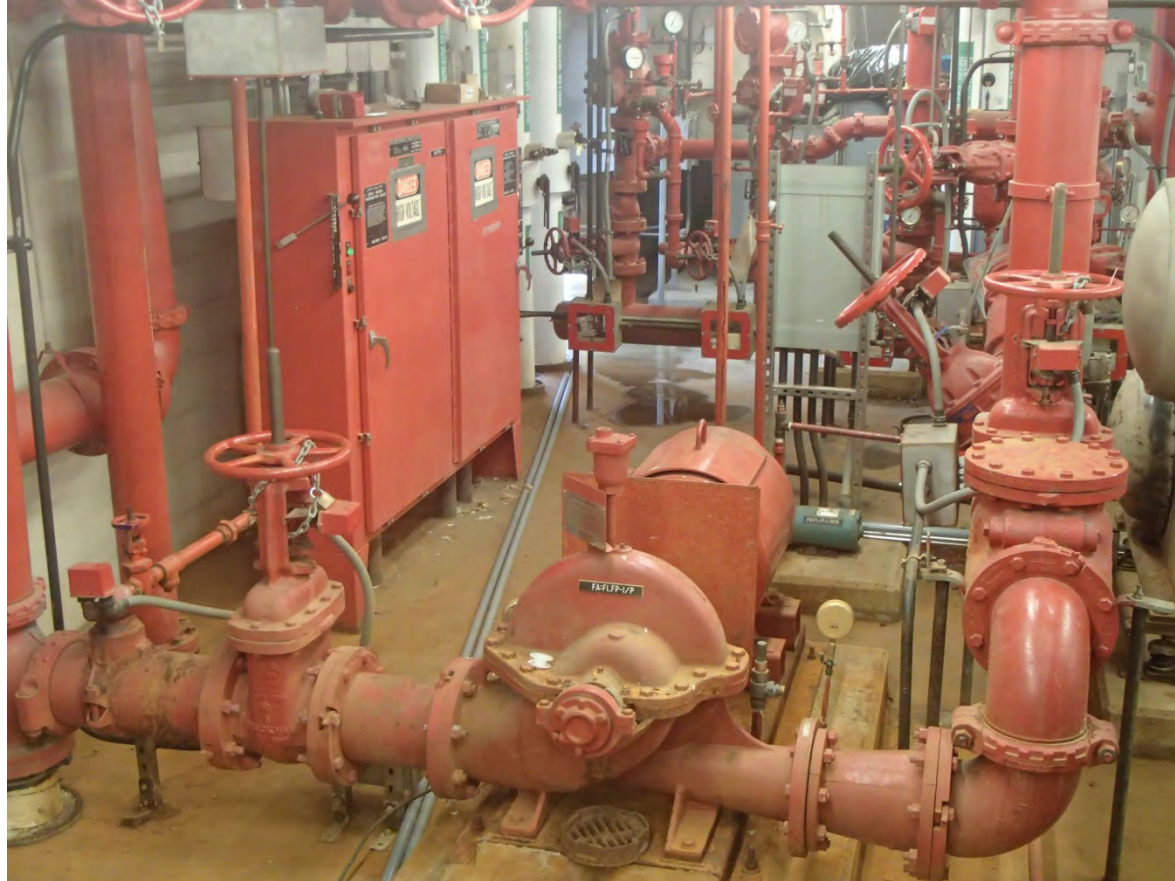
Fire Alarm Pumping system

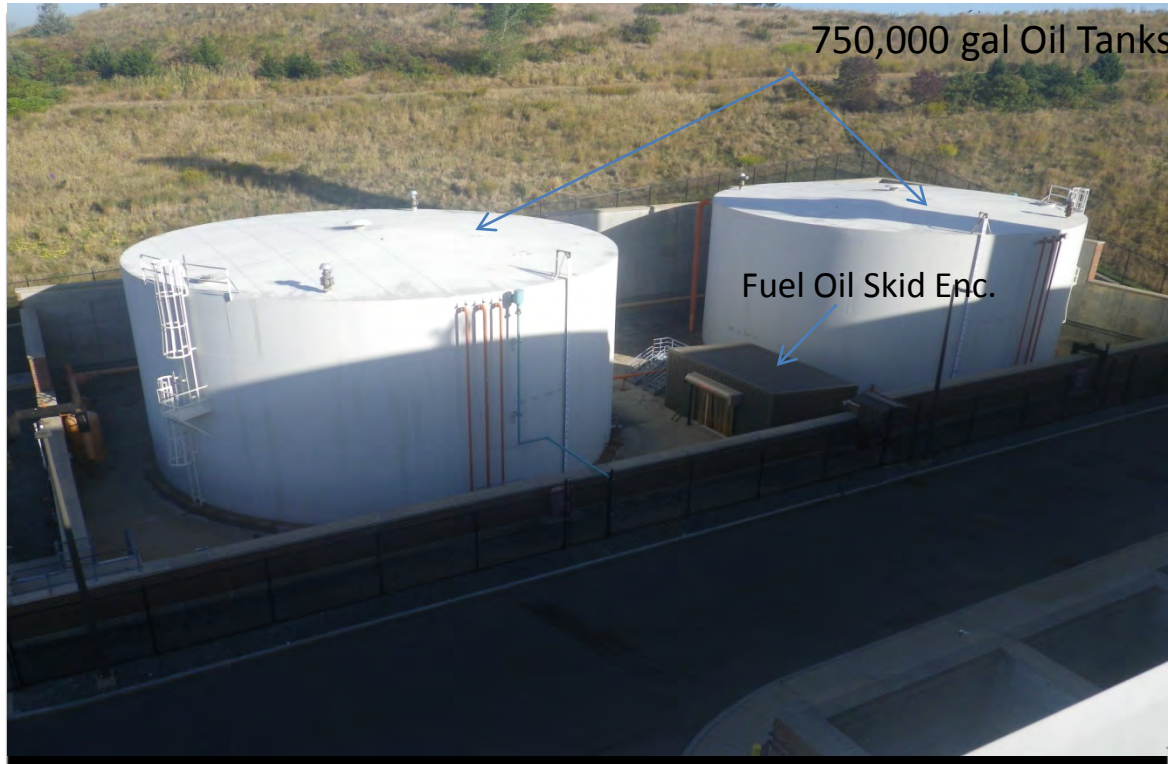
Fuel Oil Tank Farm

- Two 750,000 gal. storage tanks
- Ultra low sulfur diesel fuel
- One Existing Fuel Oil Skid; 3 pumps, 1 standby
- one buried pipeline from tanks to TPP

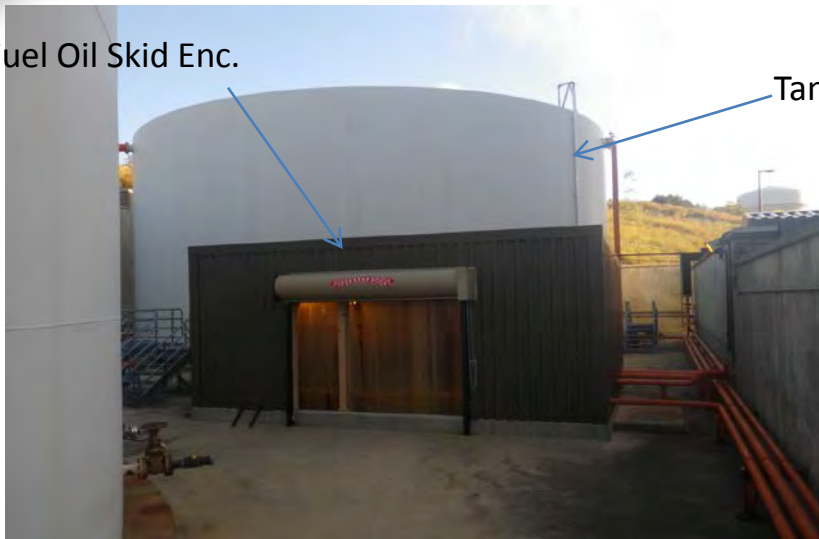
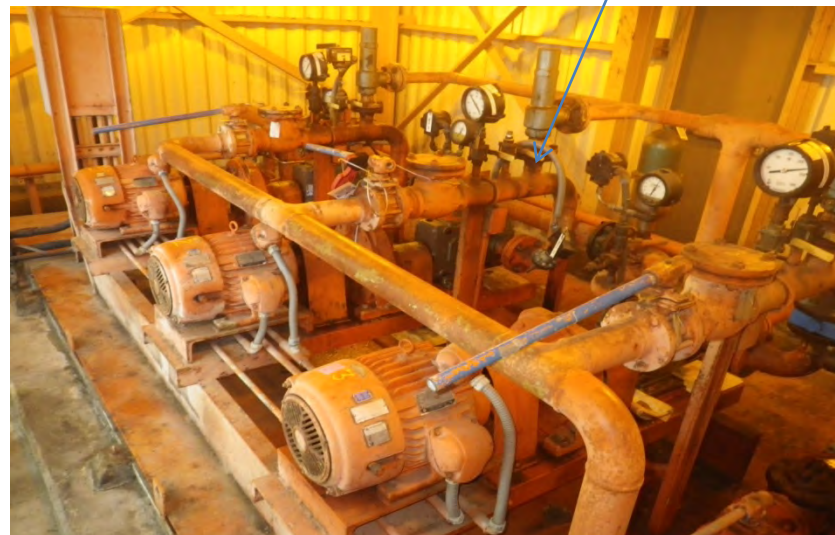
Fuel Oil Skid

Fuel Oil Skid Enc.

Tank No 101

- **Fuel Oil Pumping skid system consists of three pumps (1-standby):**
 - Provides fuel to both CTG units and boilers
 - Single point of failures
 - New Fuel Oil skid on elevated platform
 - New pipeline
 - Totally independent control systems

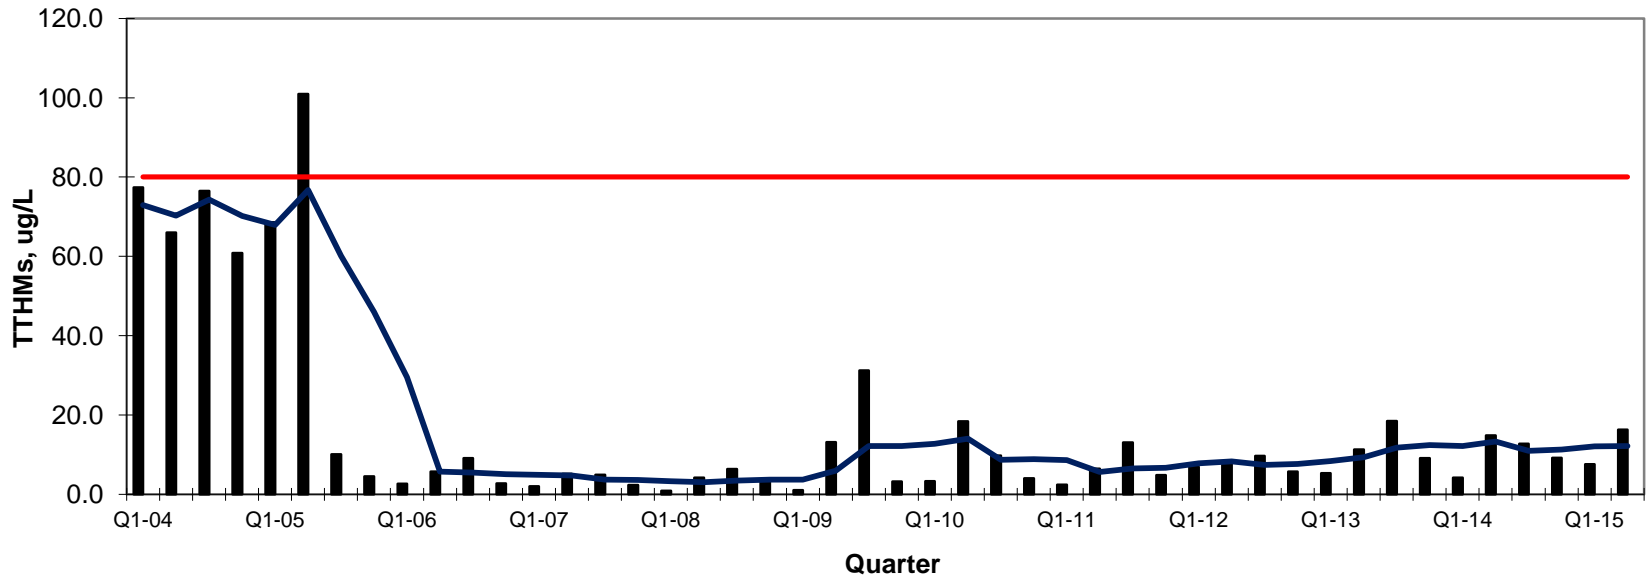
Total Trihalomethanes, Metropolitan Boston Locations Compliance Calculation

→
CWTP Online July 2005

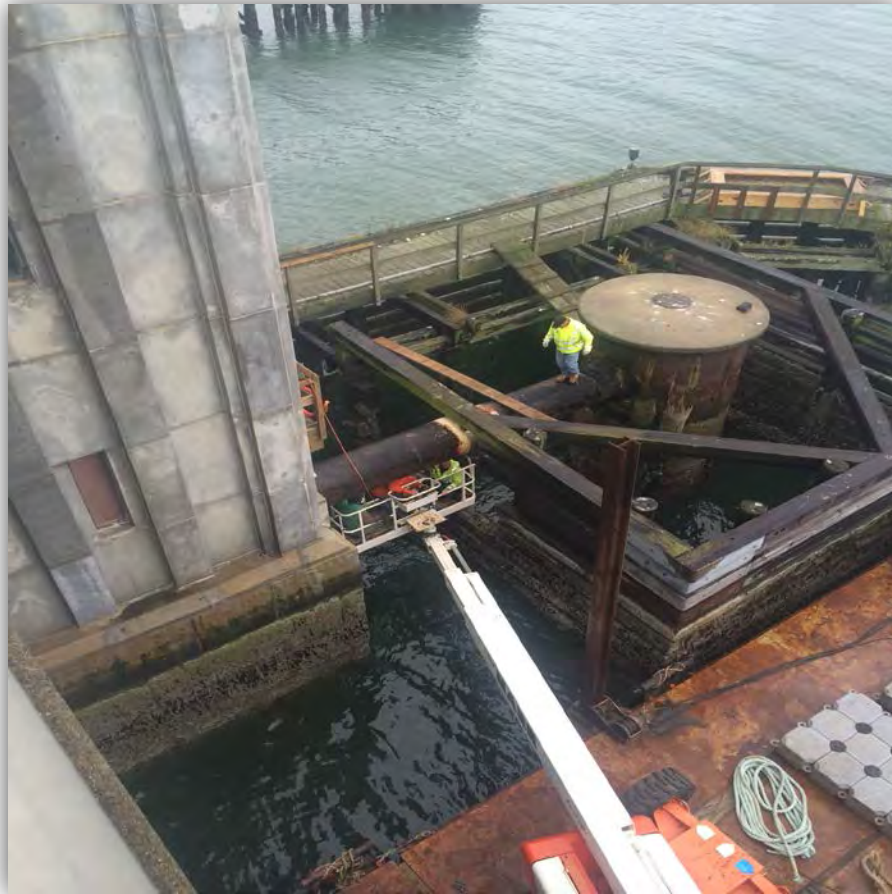
Previous Leak Repairs – Near North Tunnel Shaft, 2014

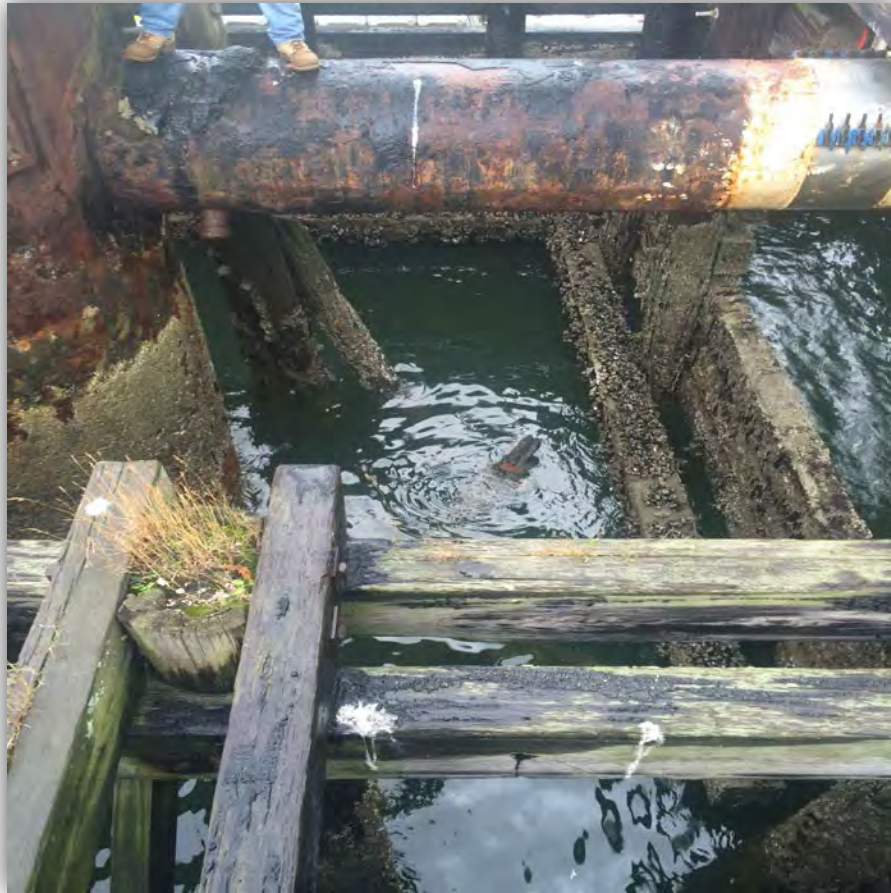
Previous Leak Repairs - Welded Plug & Mechanical Clamp, 2014

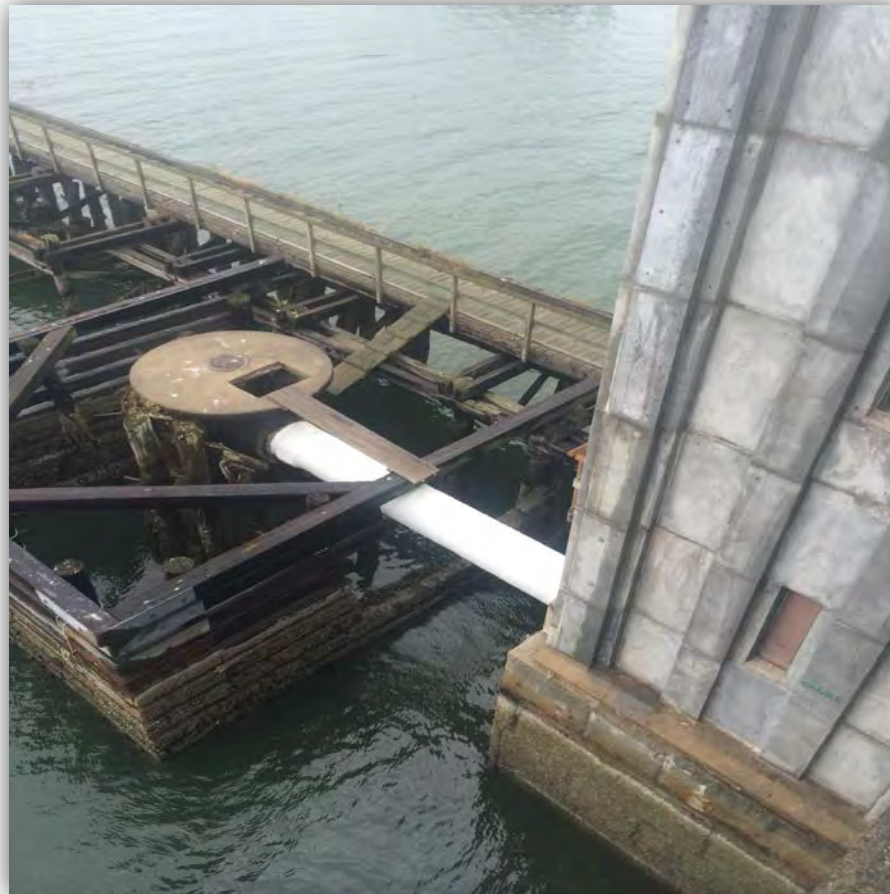
Corrosion Protection at South Tunnel Shaft, 2014

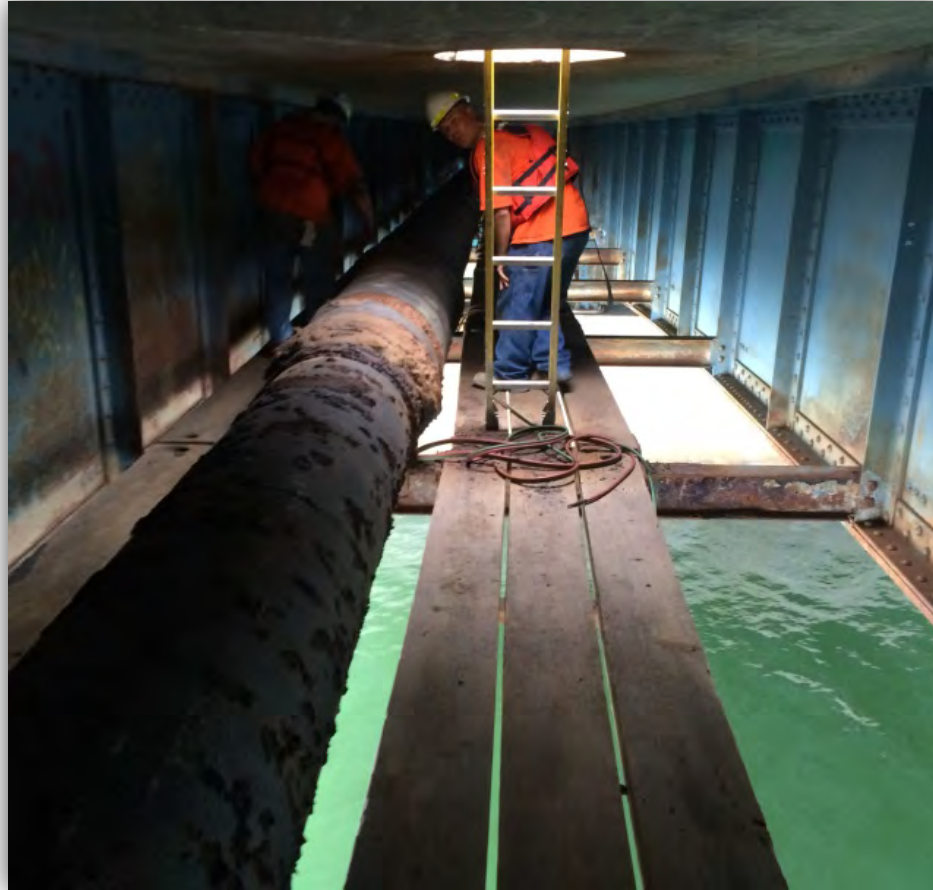
Current Condition of the Pipe Under the Bridge, 2015

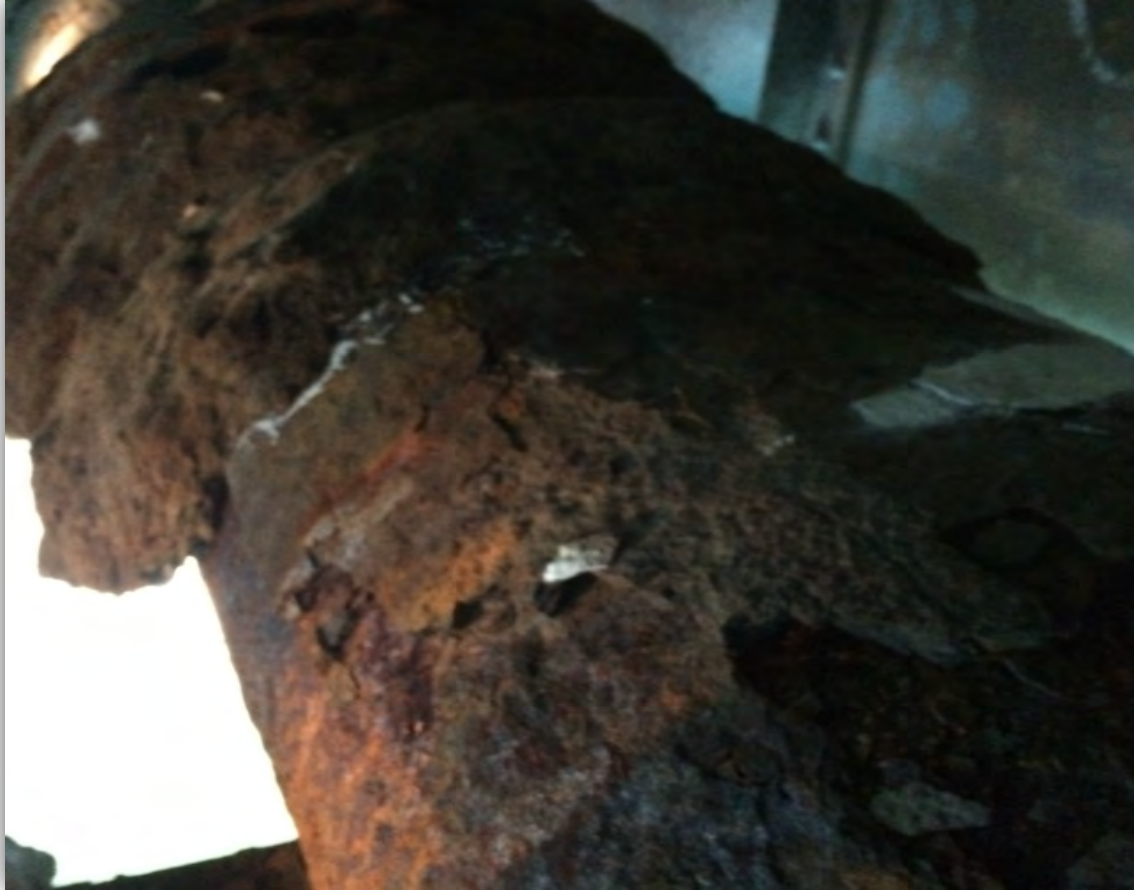
Exterior Rust and Corrosion of the Pipe Under the Bridge, 2015

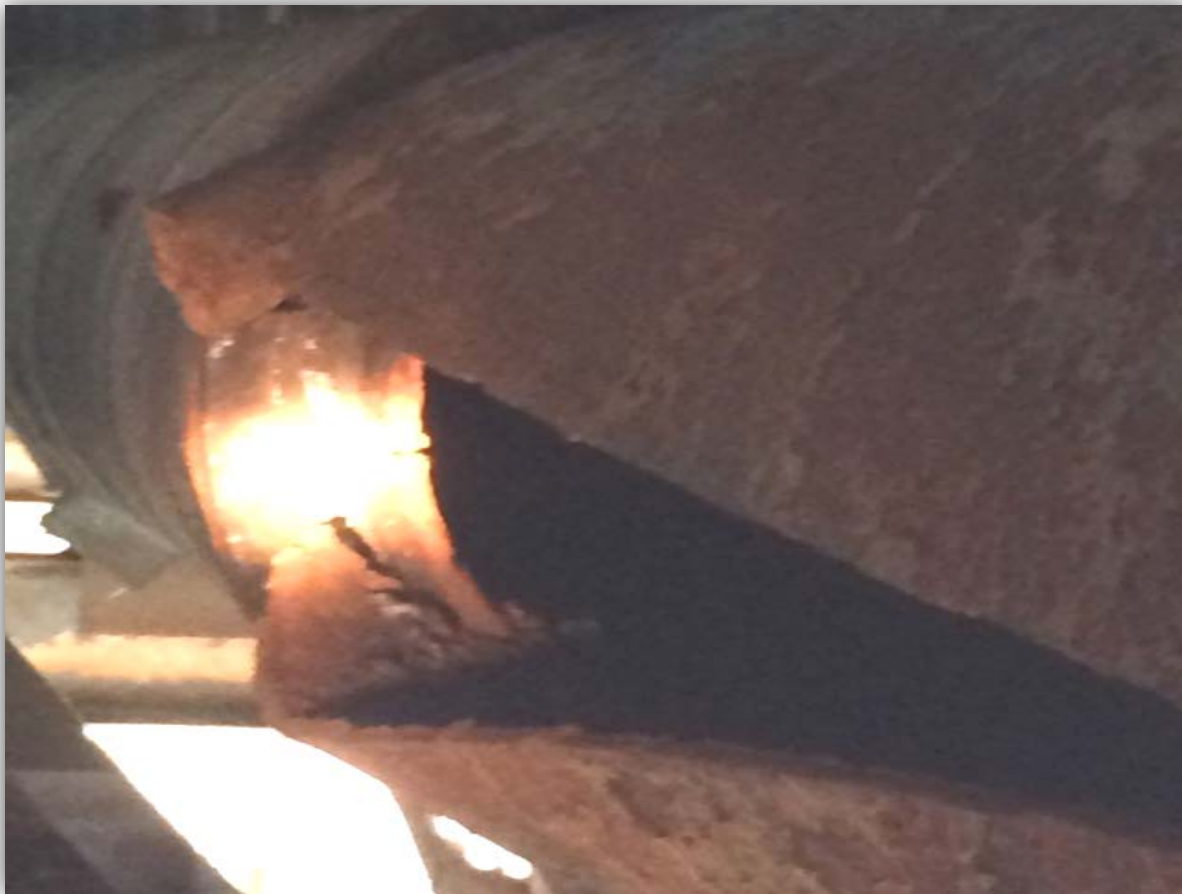
Splitting of the Pipe under the Bridge, 2015
