***Alewife Brook Pump Station Rehabilitation  
Construction Update***

***Chelsea Creek Headworks Upgrade  
Contract 7161 - Change Order 22***

***Wachusett Dam Lower Gatehouse  
Pipe Break***

***Northern Intermediate High Pipeline  
Contract 7067, Change Order 3***

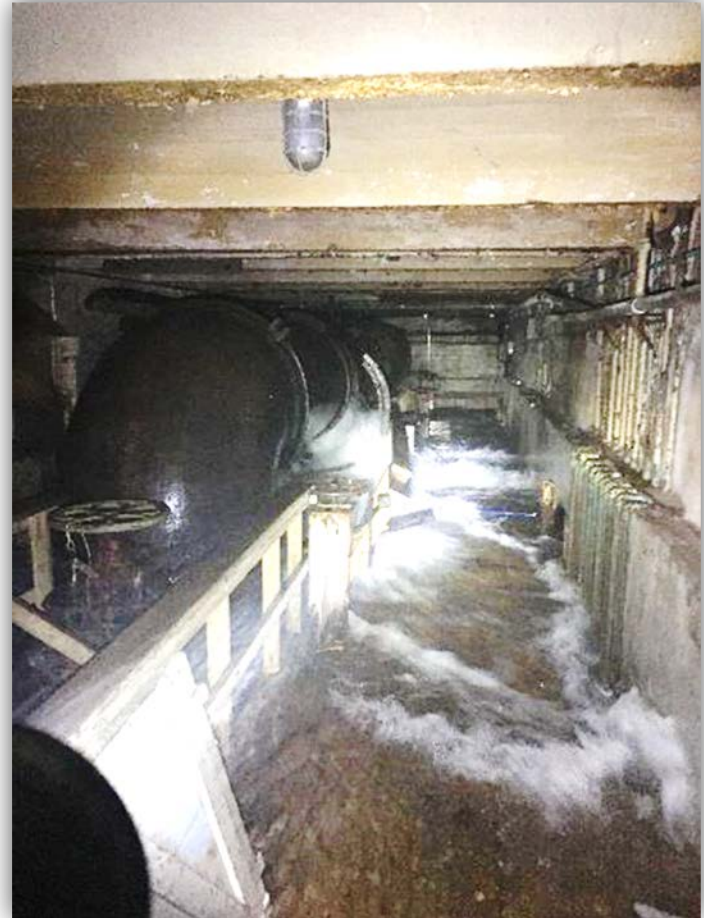
# Wachusett Dam Lower Gatehouse Pipe Break

Break of 1905 Equalizer Pipe during testing of the Wachusett Aqueduct Pumping Station

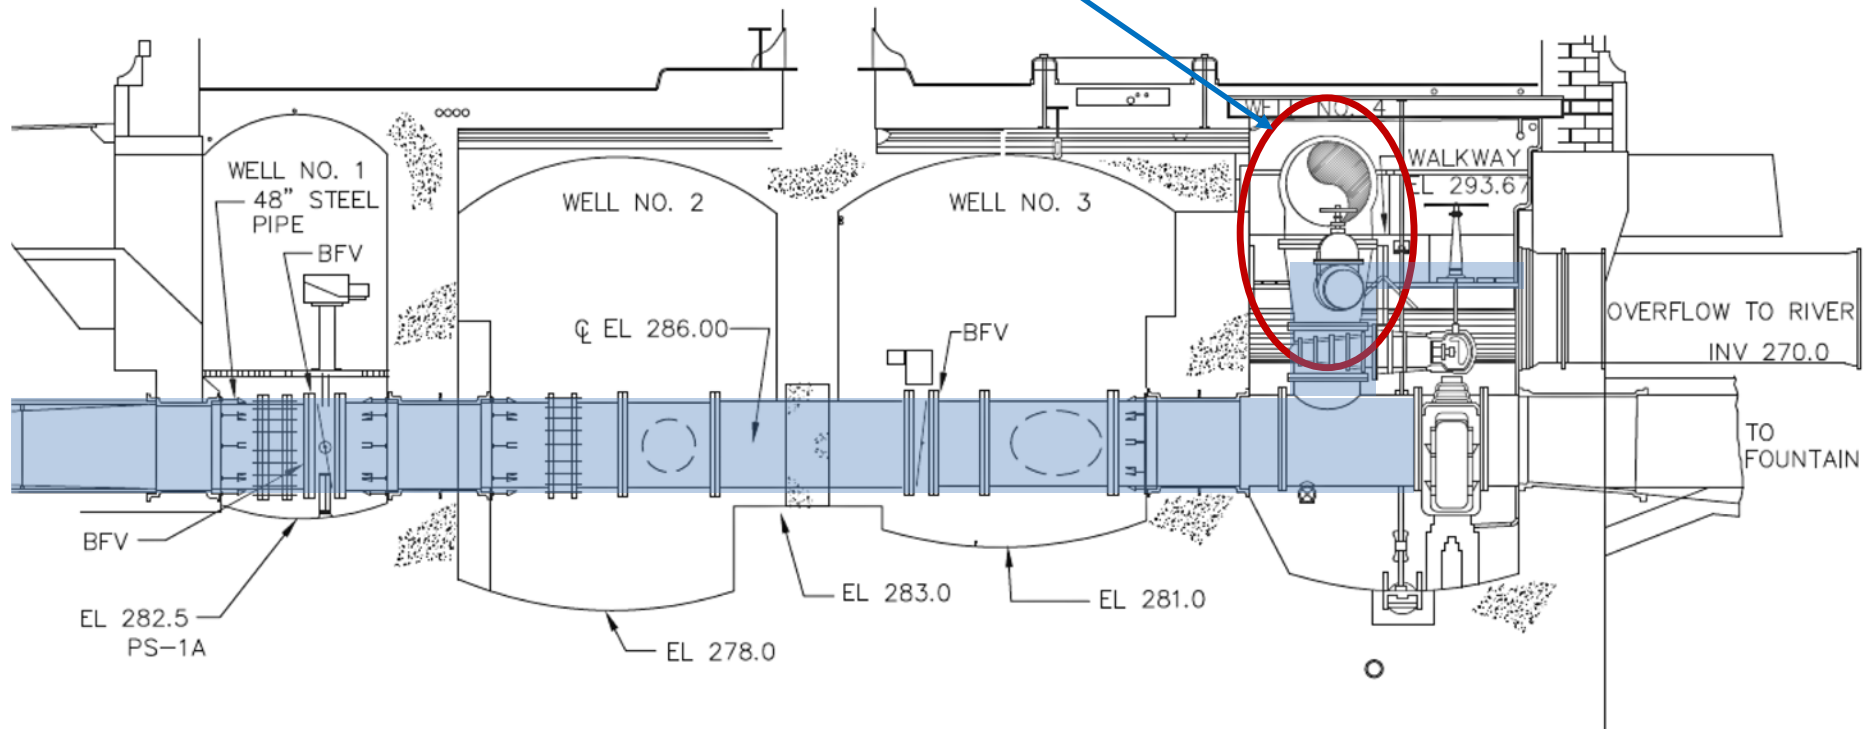
# Wachusett Dam Lower Gatehouse

Tee and Reducer Failed

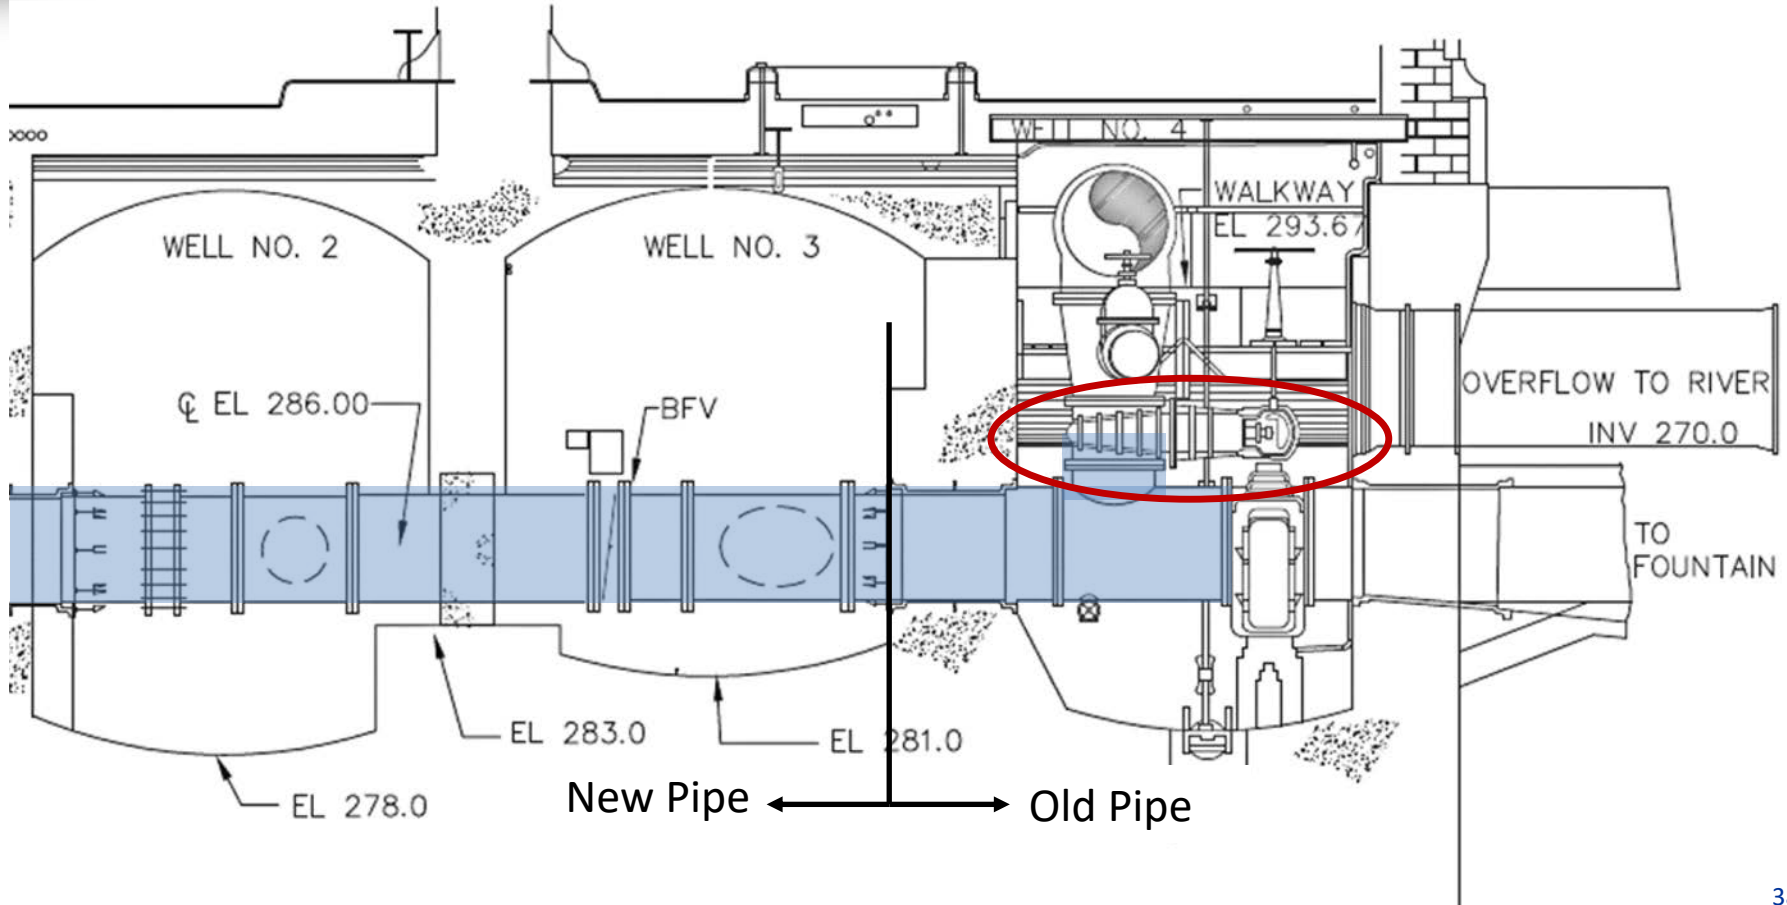
# Valve to Equalizer Pipe

1. Close the valves on Lines 1 and 2 to isolate water from the equalizer pipe. Test pipe integrity
2. Install blind flanges on Lines 1, 2 and 3

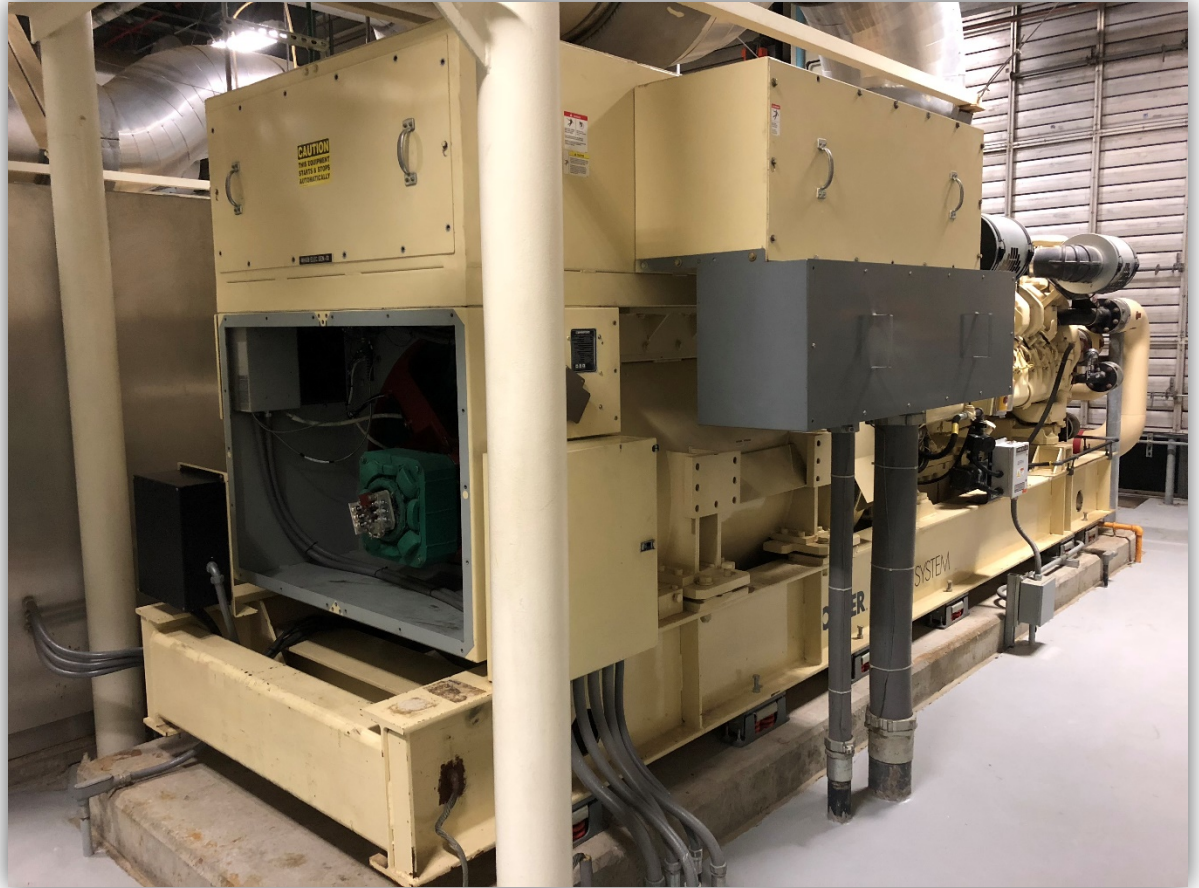
# Carroll Plant Electric Generator No. 1

- Replacement of Generator No. 1 is required following attempts to repair it
- All four generators needed to power Carroll plant and Wachusett Aqueduct Pumping Station at full capacity
- Contract for replacement advertised

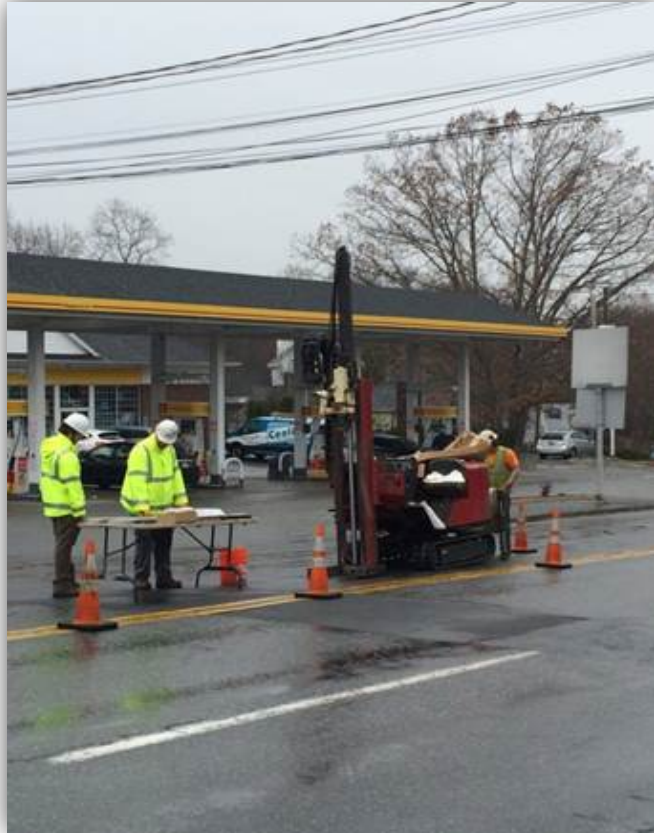
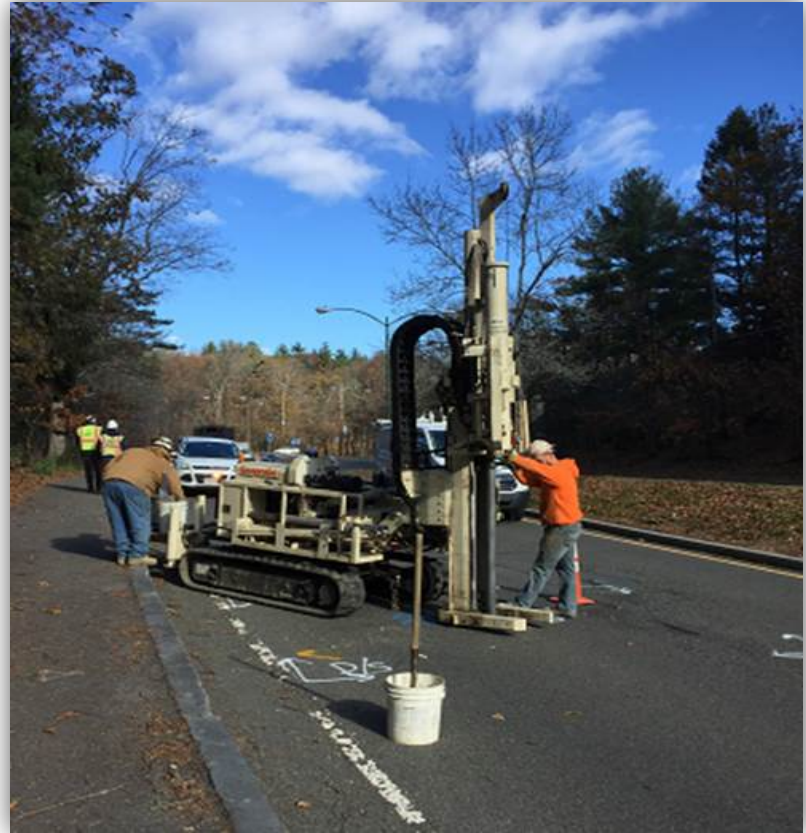
# Soil Borings to Pre-characterize Soil

- Soil sampling occurred from Cottage Street at Montvale Avenue to Main Street at South Street
- DCR would not allow soil testing along South street, Pond Street and Woodland Road during design
- Design Engineer estimated that material was clean

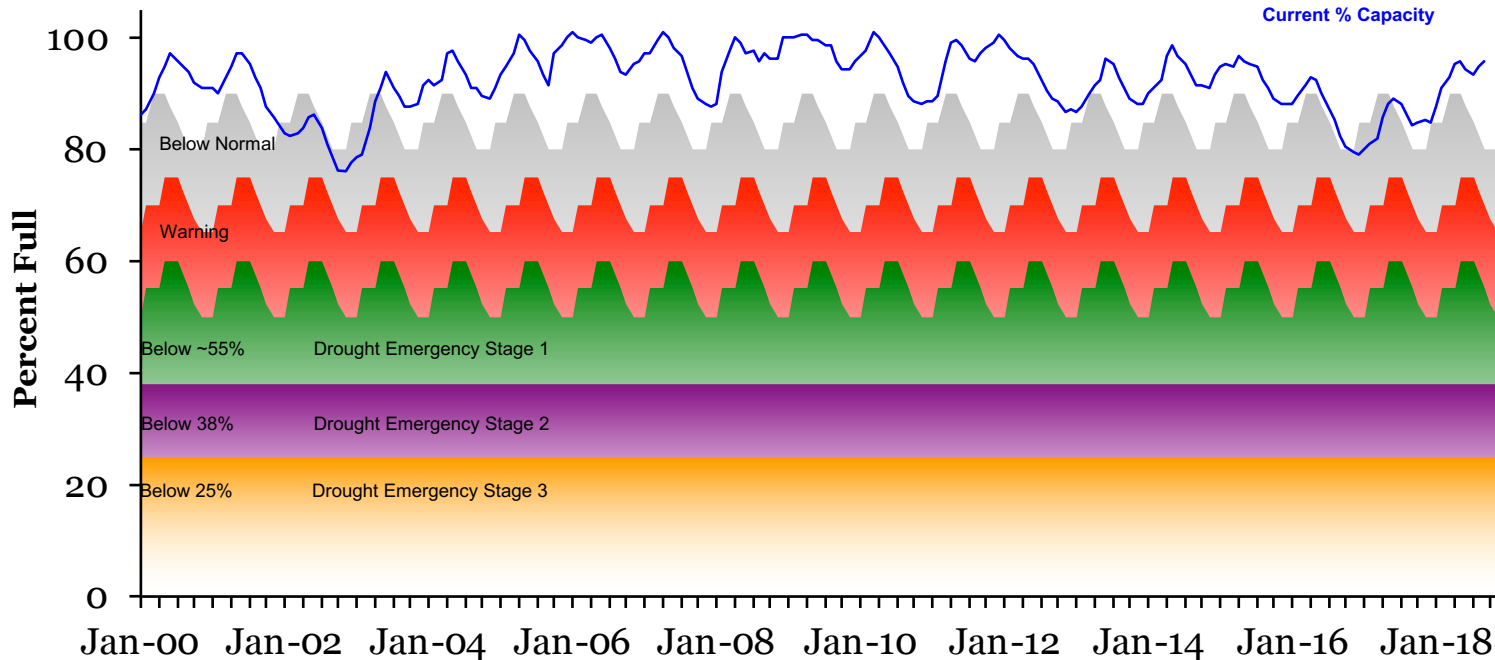
## Quabbin Reservoir Levels With Drought Emergency Planning Stages

# Quabbin is well within normal operating Range

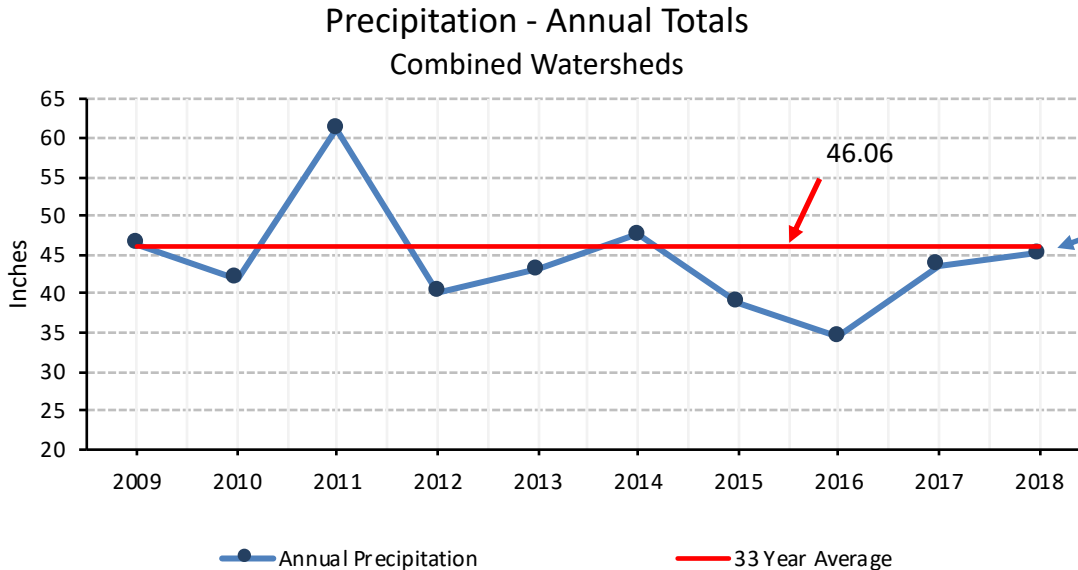
## 2018 – will close as a wetter than normal year

Through the end of  
October 2018

Wachusett received 5.38" so far in November and Quabbin has received 4.12"

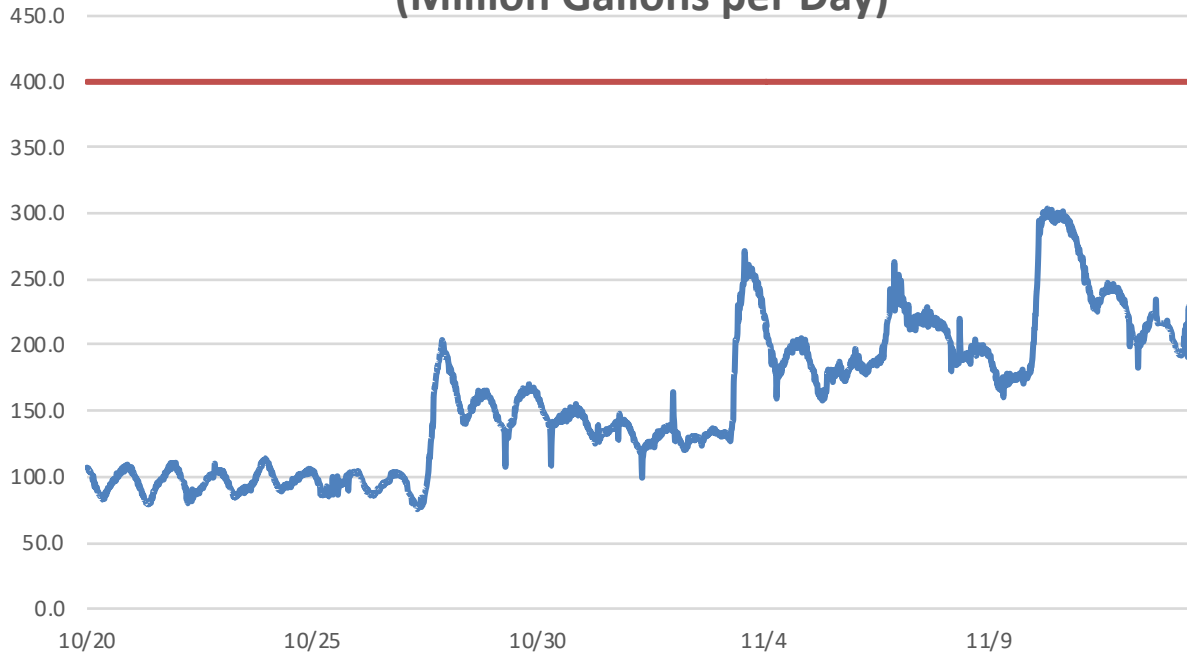
## South System Flow to Deer Island (Million Gallons per Day)

# Flow Increasing

— South System Flow, MGD

— South System Design Max, MGD
