*Storm Impacts on MWRA's Wastewater System  
and Receiving Waters*

September 13, 2023

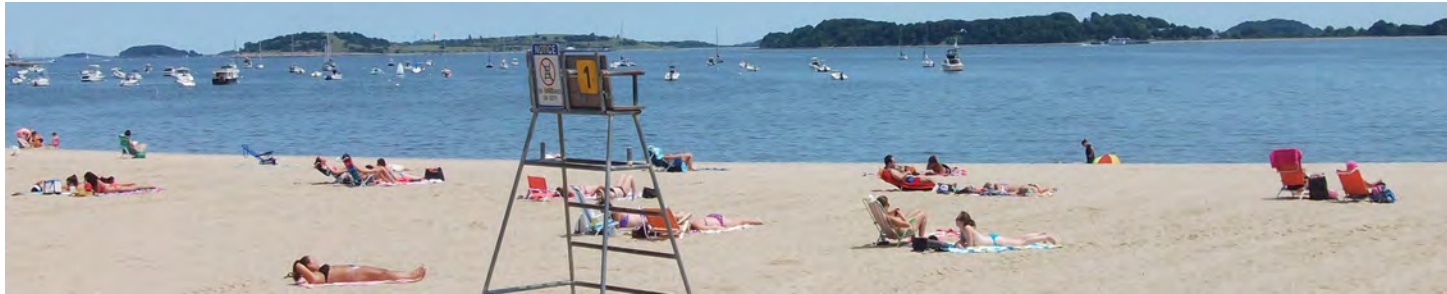
- The majority of CSO discharges receive partial treatment (screening, some solids removal, disinfection and dechlorination)
- CSO is mostly stormwater
- **There are no CSO discharges to the Boston area Beaches**
- But there are stormwater discharges to several beaches: Wollaston, Tenean, Malibu, and Constitution

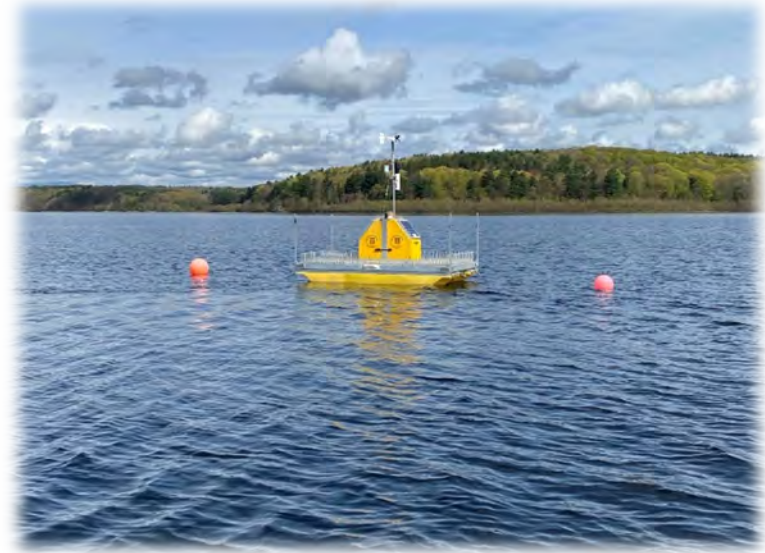
- Transfers of Quabbin water through Wachusett creates a band of high quality water (interflow)
- Benefits include decreases in UV254, and reduced ozone and chlorine demand
- Since July, precipitation events have reduced our ability to maintain higher transfer rates
- Buoy monitoring stations are helpful to watch water quality trends

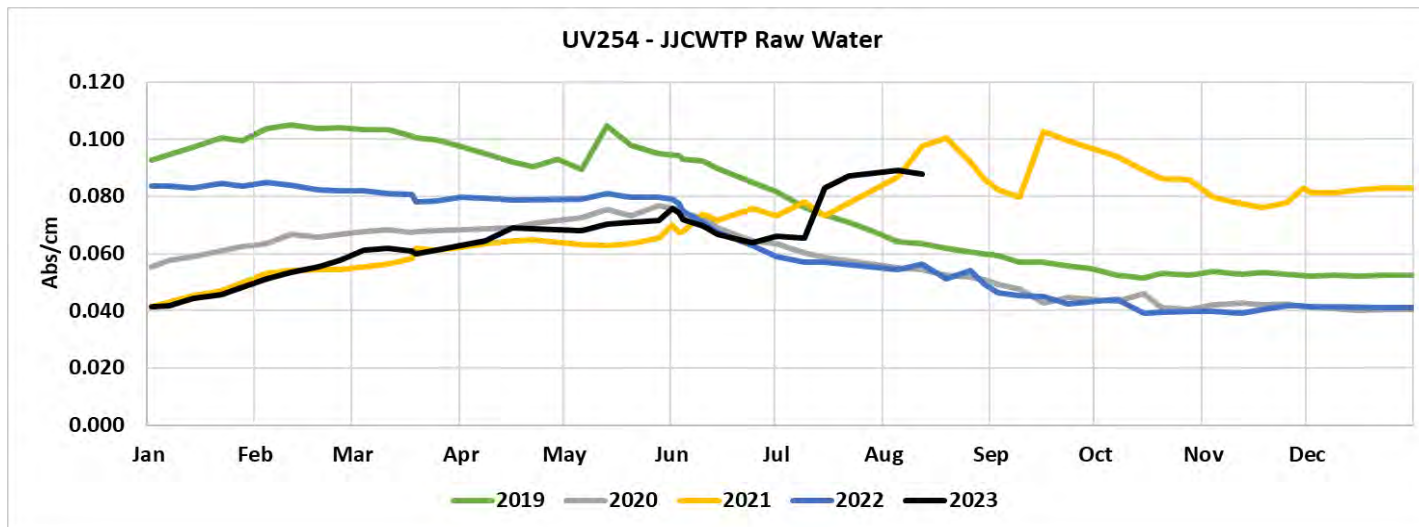
- Elevated UV254 results in increased ozone demand, chlorine demand & decay, lead solubility
- Current UV254 levels
  - Quabbin 0.024 Abs/cm, Wachusett 0.095 Abs/cm

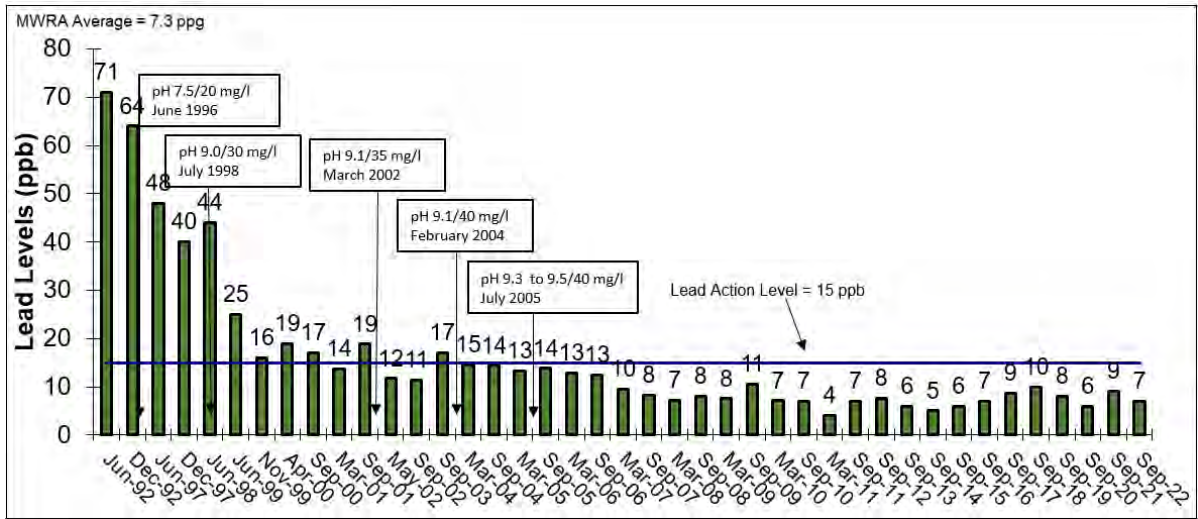
90<sup>th</sup> Percentile Lead in MWRA Fully Served Communities

- Current corrosion control includes pH and alkalinity adjustment
- 90% reduction in lead levels since mid-1990's

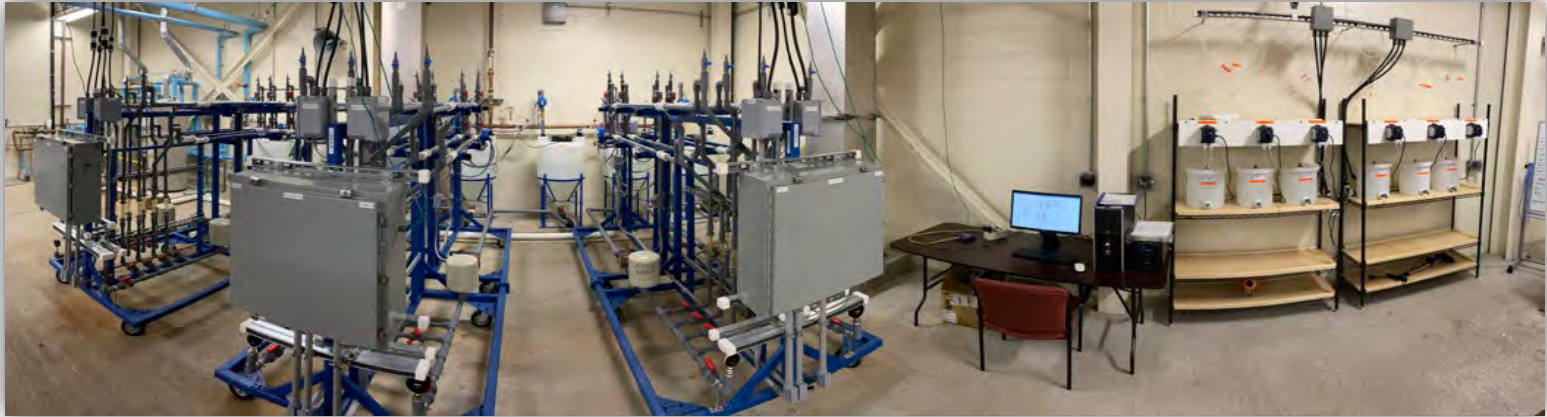
- Evaluating potential treatment alternatives to meet current and future requirements
- MWRA staff constructed 6 pipe rigs with Lead Service Lines collected from Boston homes
- Expert panel assembled to assist with evaluation

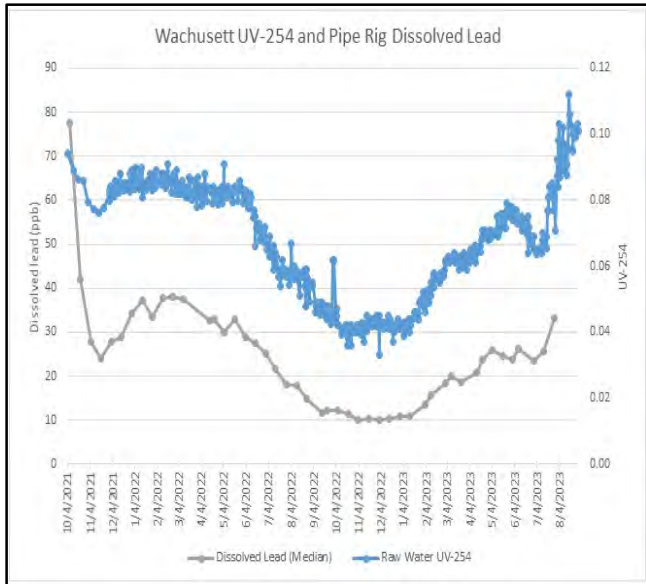
- Study data appears to correlate lead levels with raw water organic matter (measured by UV254)
- Current UV254 levels are high:
  - Decreased transfers from Quabbin Reservoir as a result of summer wet weather
  - Potential for Trigger or Action Level exceedances in communities samples

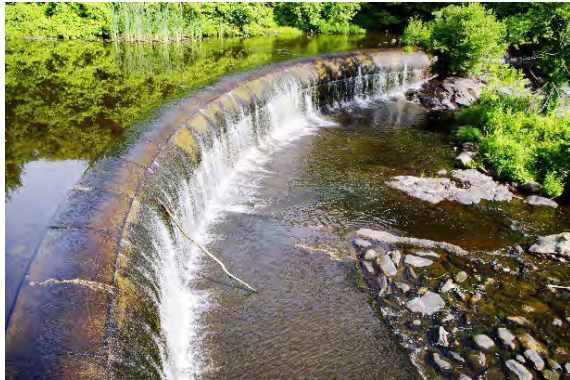
Quinapoxet River  
Dam

- 250-foot long, 18-foot high structure and fish ladder
- Removal of dam and fish ladder will restore the Quinapoxet River to its natural conditions
- Open 35 miles of coldwater fish habitat
- Add new ADA accessible pathway and fishing platform
