MWRA Board of Directors

*Preferred Service Agreement for
Deer Island's Combustion Turbine Generators,
Mitsubishi Power Aero LLC*

*Nut Island Headworks
Odor Control and HVAC System Improvements
Contract 7548 - Change Order 20*

*Report on 2024 Water Use Trends and
Reservoir Status*

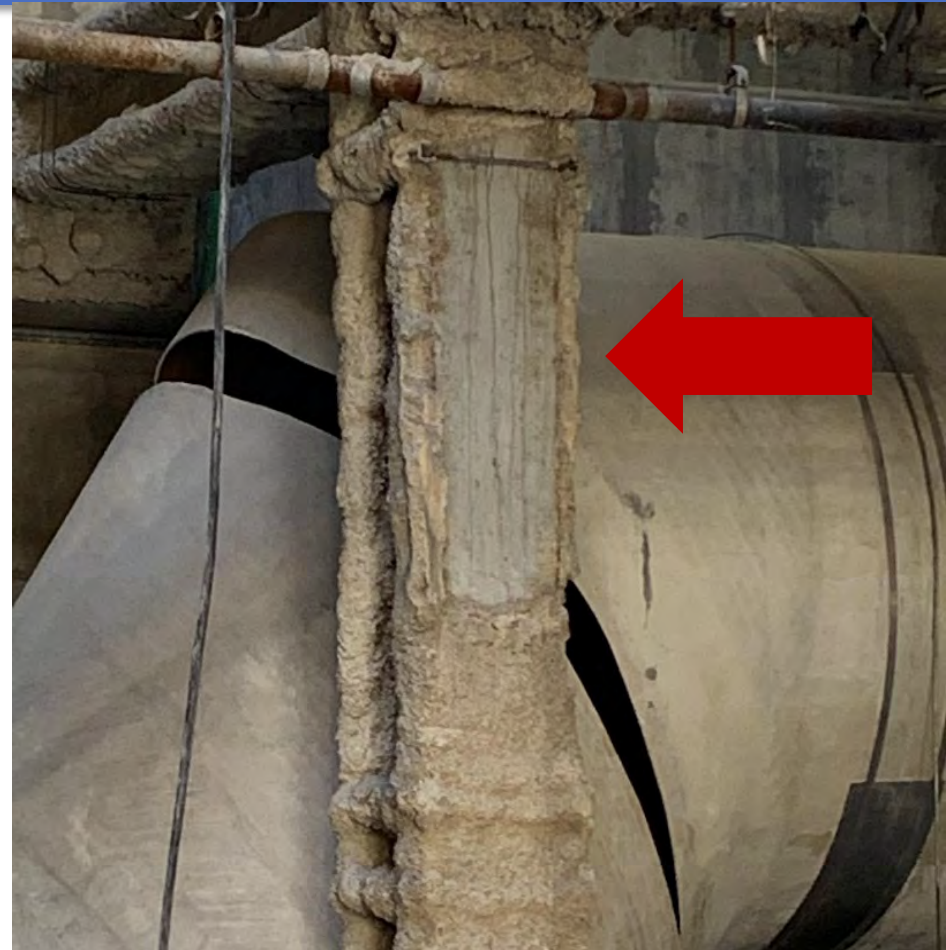
Existing Fireproofing Deficiencies

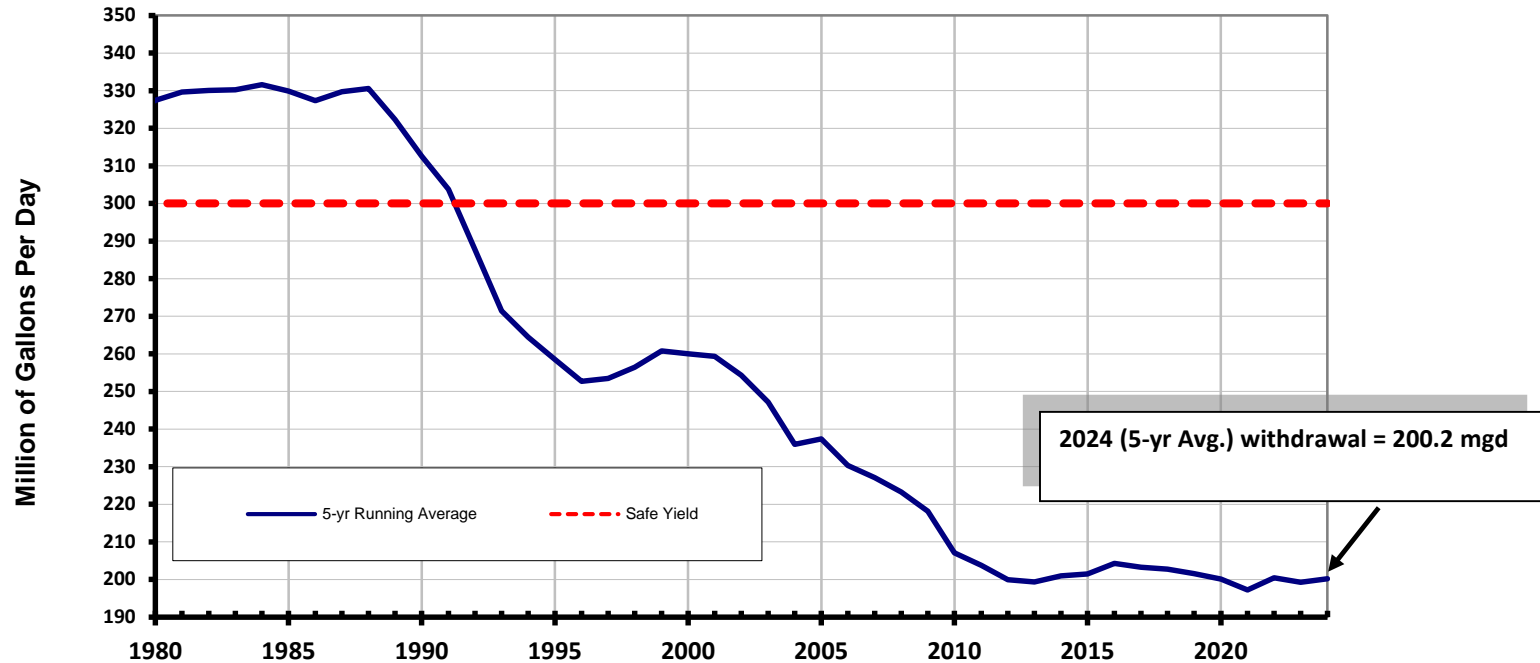
Reservoir Withdrawals Dropped Substantially Since 1980's

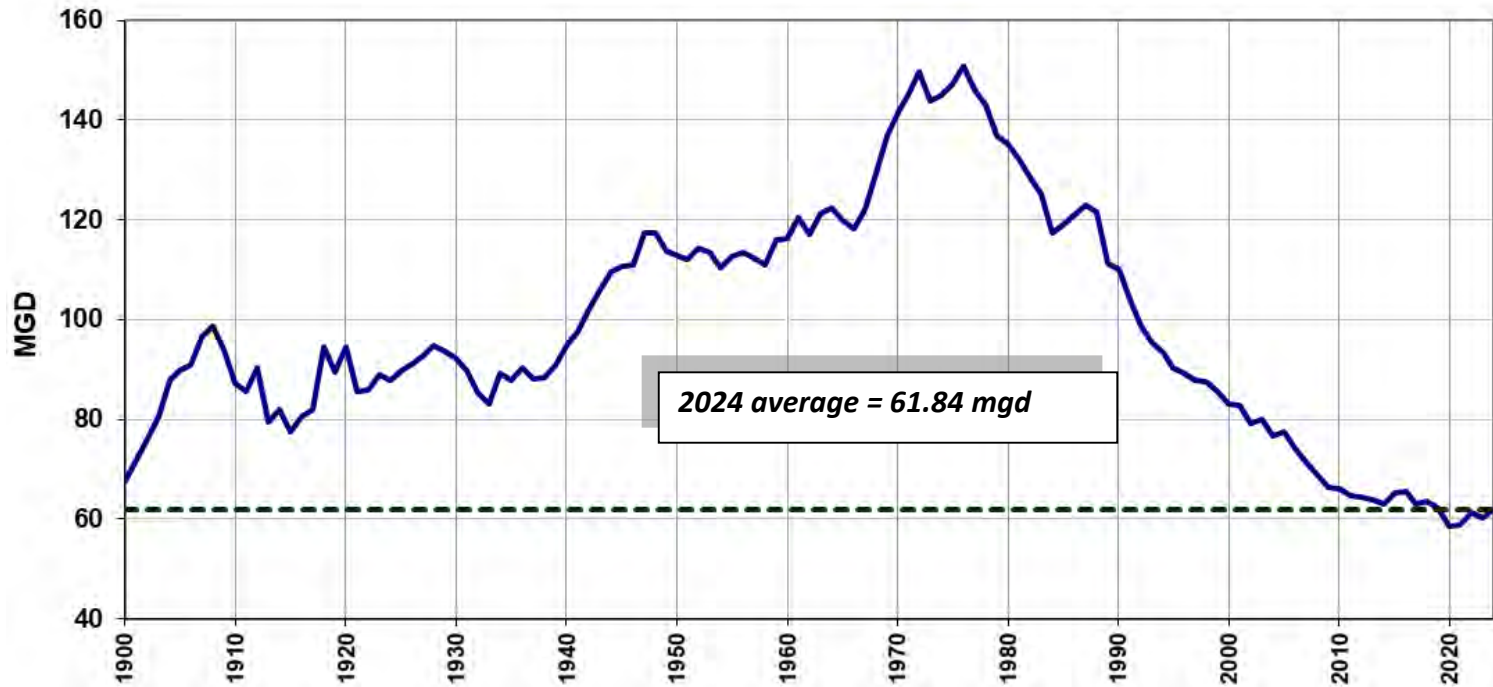
Boston Water Use (1900 to 2024)

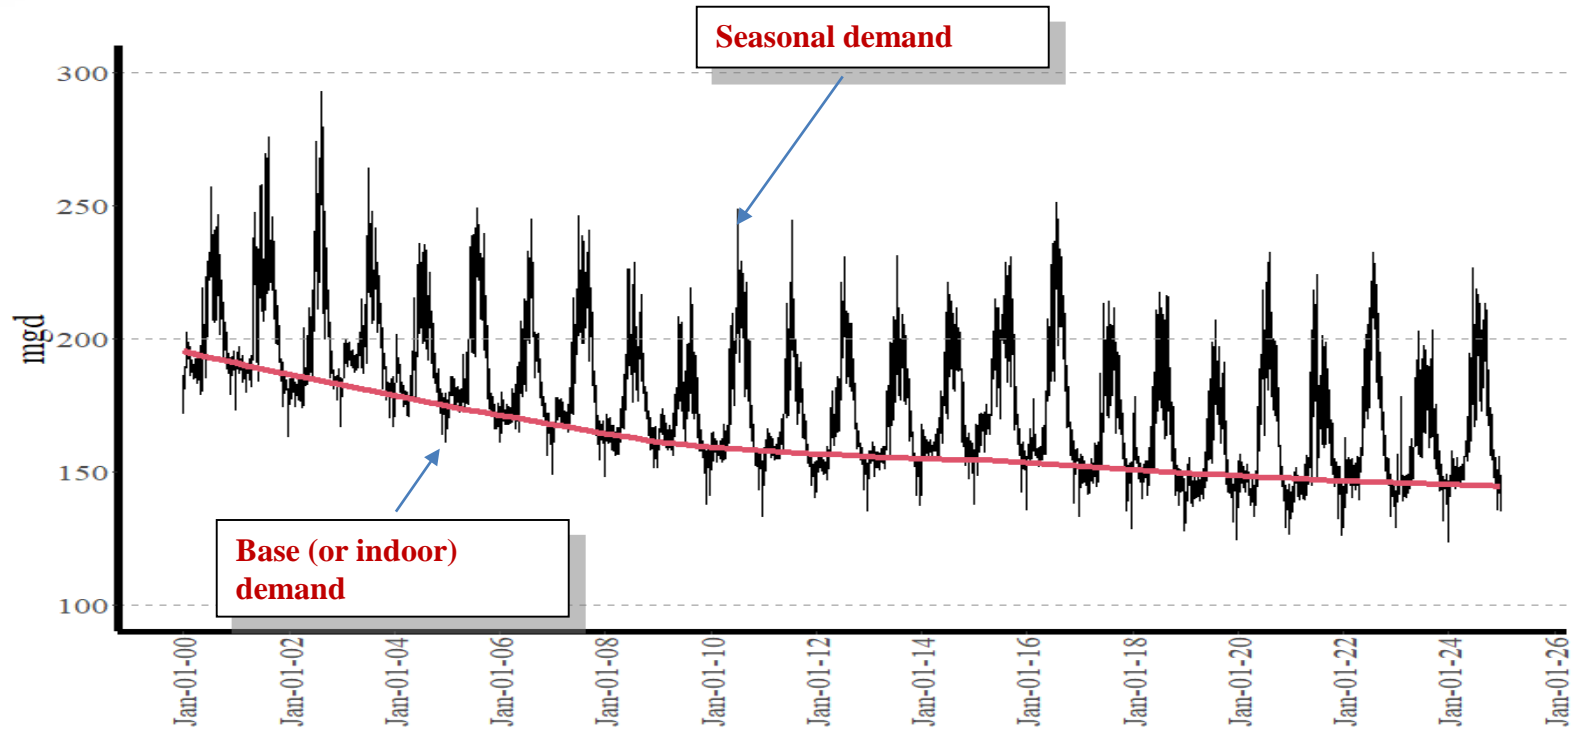
Base (Indoor) Demand vs. Seasonal Demand

Based on daily demand from fully supplied communities (2000 to 2024)

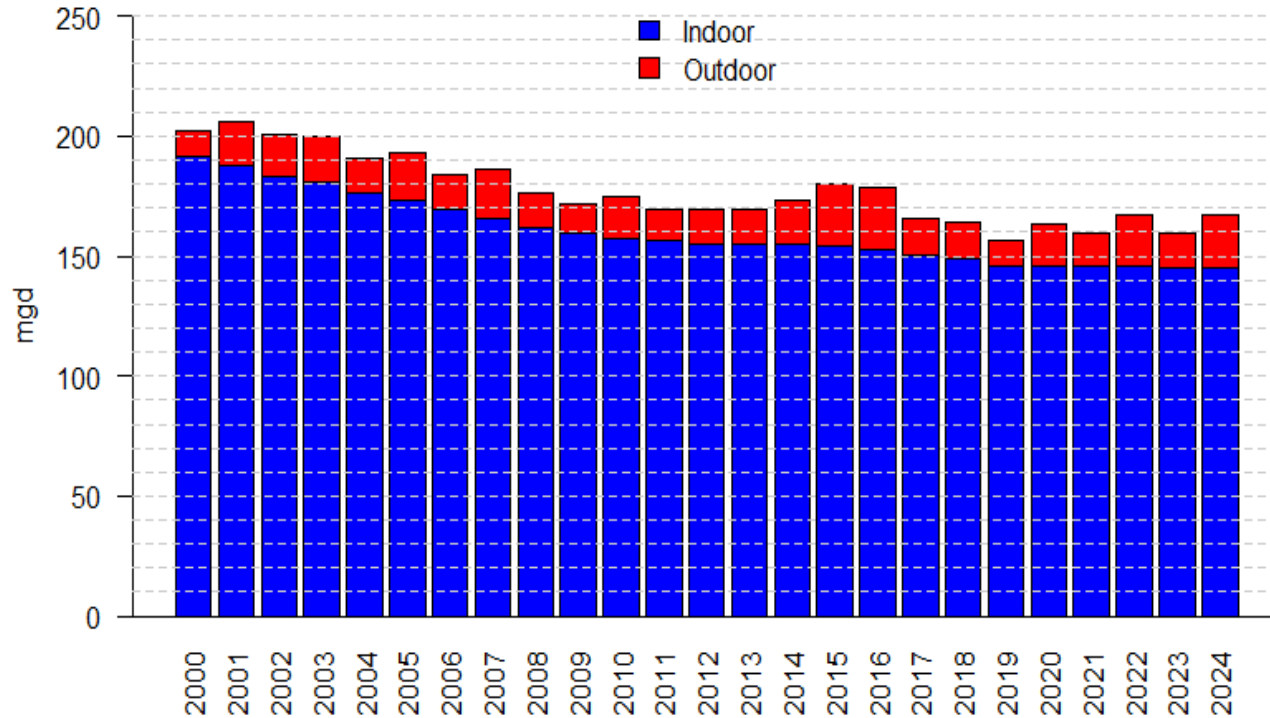
Fully Supplied Communities (Annual Base and Outdoor Use)

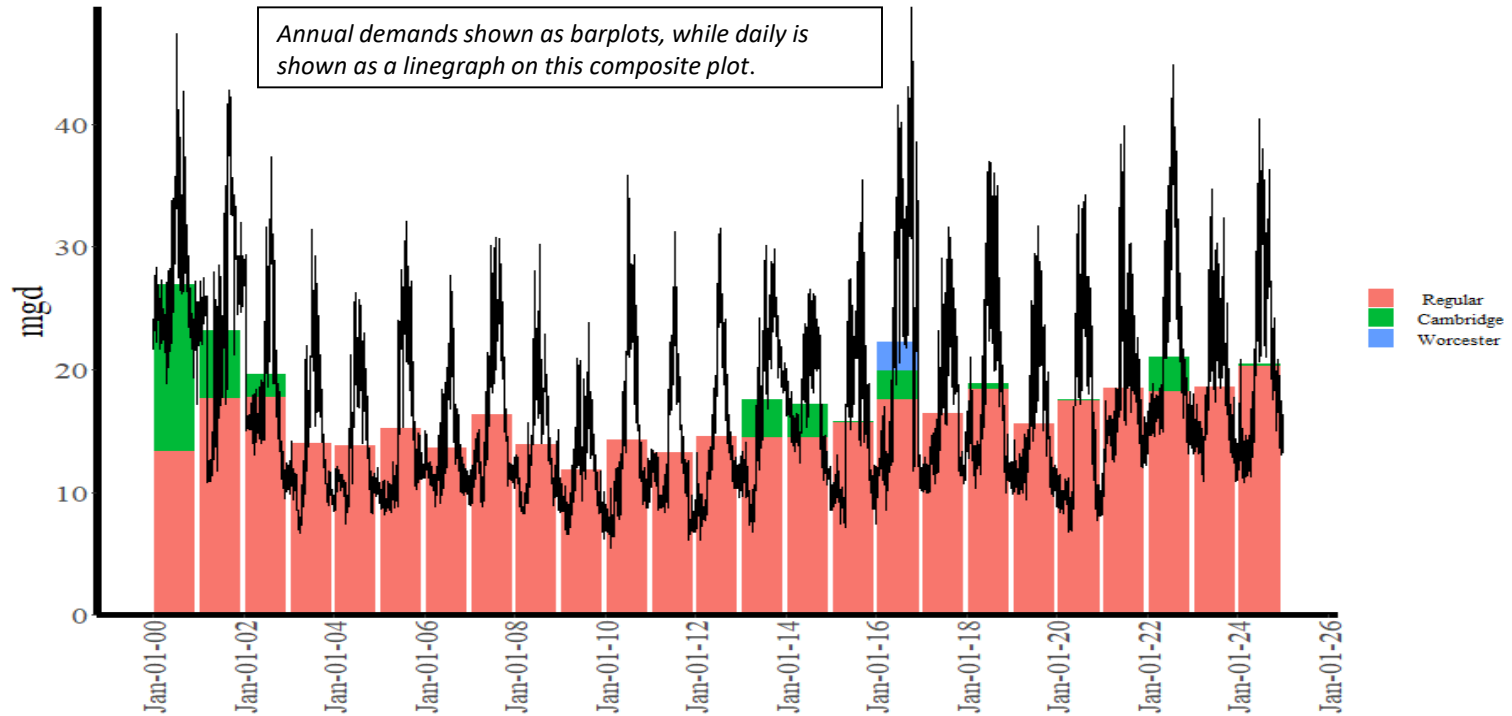
Partially Supplied Communities Have More Variable MWRA Demand

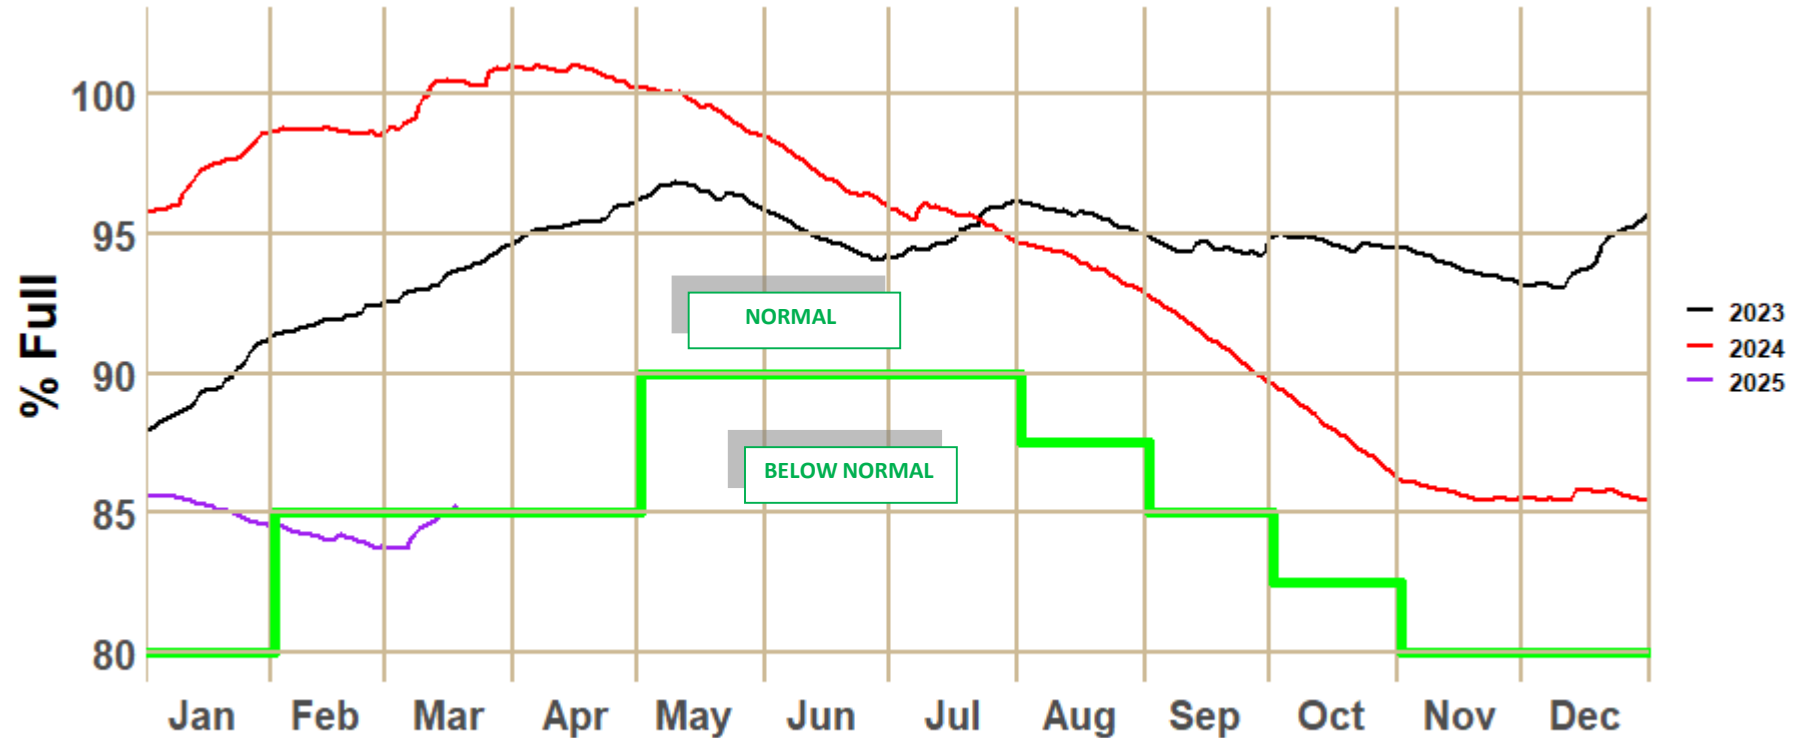
Quabbin stayed within Normal Operating Range during 2024

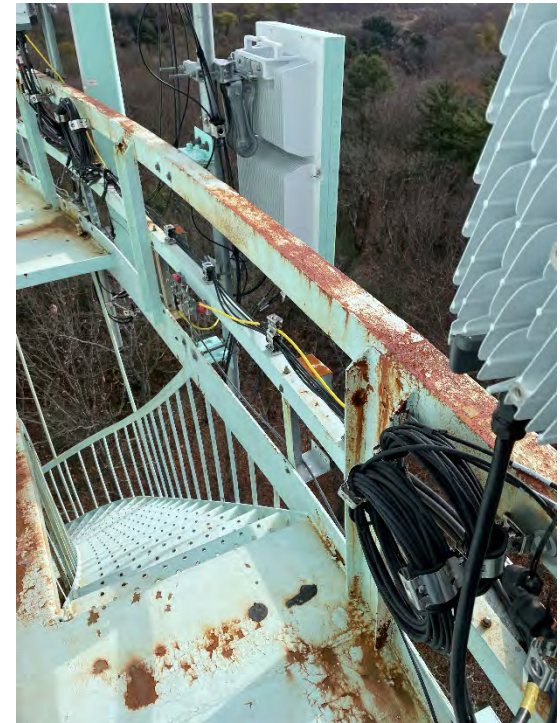
Corroded Guardrail, Stairs & Platform

- Interior and Exterior Abrasive Blast Cleaning and Painting
- Structural Improvements
 - Steel plate, pit, and seam repairs
 - Steel beam replacement
 - Internal tie rod replacement
 - External stairs, platform and guardrail repairs
- NSF61-Certified Impressed Current Cathodic Protection System

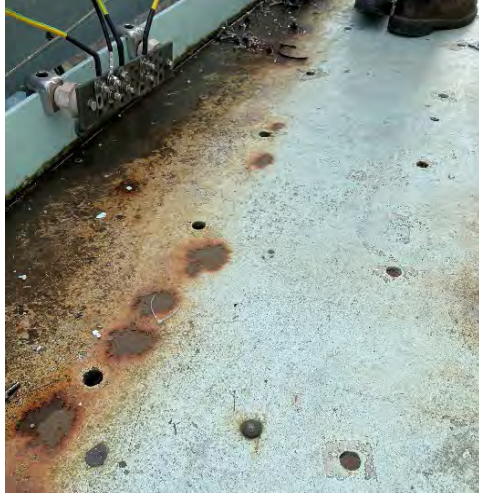
Corroded Exterior Platform

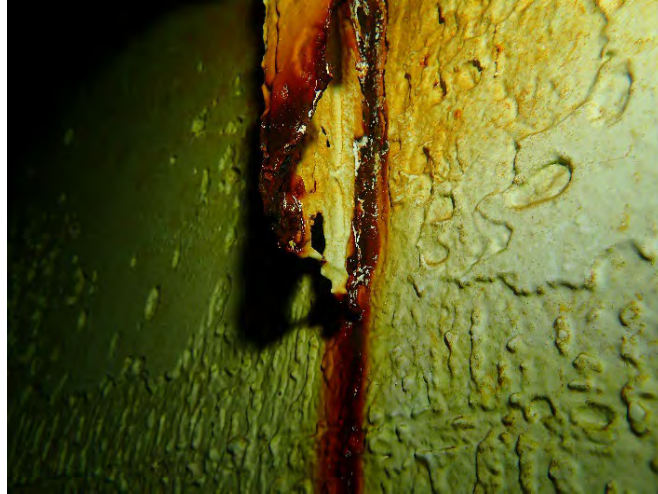
Pitting of Interior Tank Coating

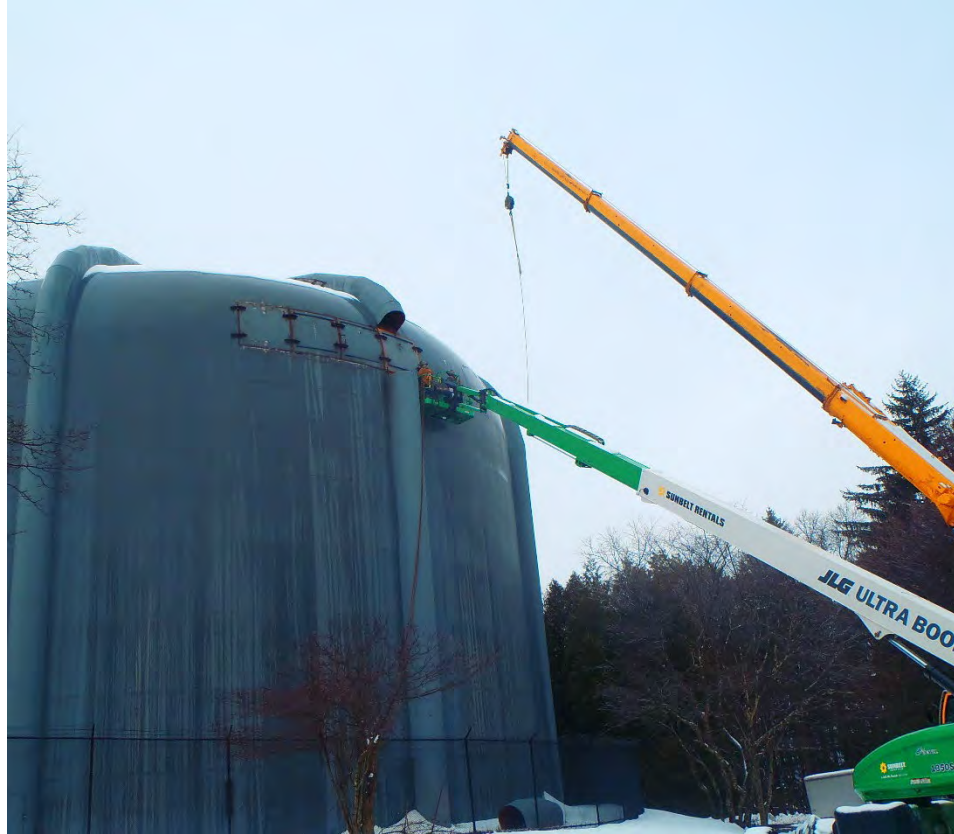
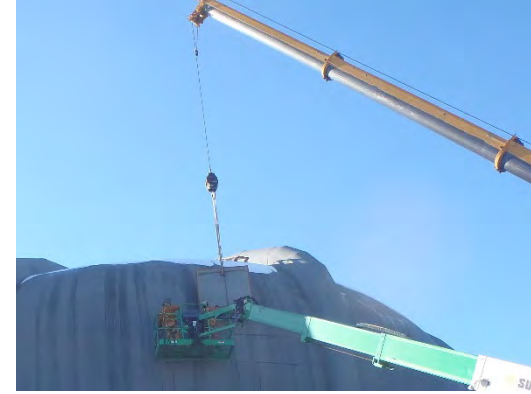
Steel Plate Repairs – Bellevue Tank

Steel Plate Rigging
