### Massachusetts Water Resources Authority

#### **MWRA Board of Directors**

## Shaft 5A Pipe Break

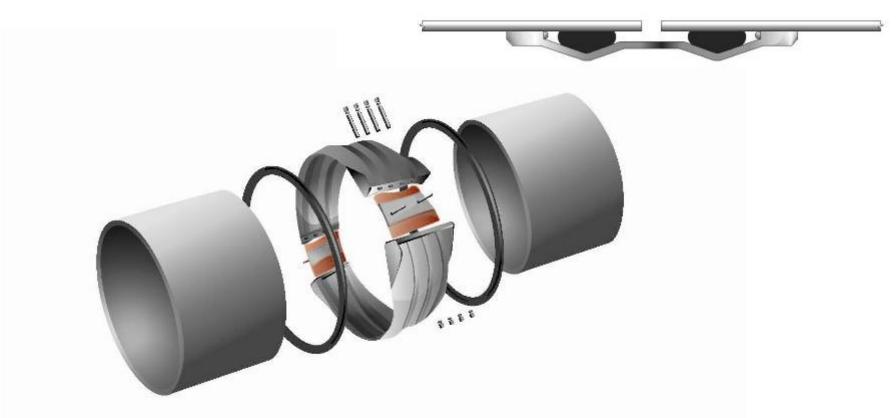
## PIPE BREAK AND REPAIR

EVENT	DATE/TIME
Leak Detected on Security Cameras	May 1/10:00 am
Total Line Shut Down	May 1/6:40 pm
Dewatering of Flooded Area Complete	May 1/10:00 pm
Pipe and Repair Collar Preparation for welding begins	May 1/10:00 pm
Pipe and Collar Preparation Completed	May 2/9:15 am
Welding of Collar on Bottom Half of Pipe Begins	May 2/10:00 am
Welding of Collar on Bottom Half of Pipe Complete	May 2/10:00 pm
Chlorine Addition Complete	May 2/11:00 pm
Welding of Collar on Top Half of Pipe Begins	May 2/11:00 pm
Concrete Cradle Pour Begins	May 2/Midnight
Concrete Cradle Pour Complete	May 3/12:45 am
Welding of Collar on Top Half of Pipe Complete	May 3/4:00 am
Filling of Pipe Begins	May 3/4:00 am
Filling of Pipe Complete	May 3/4:30 am
Pipe Pressure Test Begins	May 3/4:30 am
Pipe Placed into Service	May 3/5:30 am
Flow Fully Restored	May 3/6:15 am

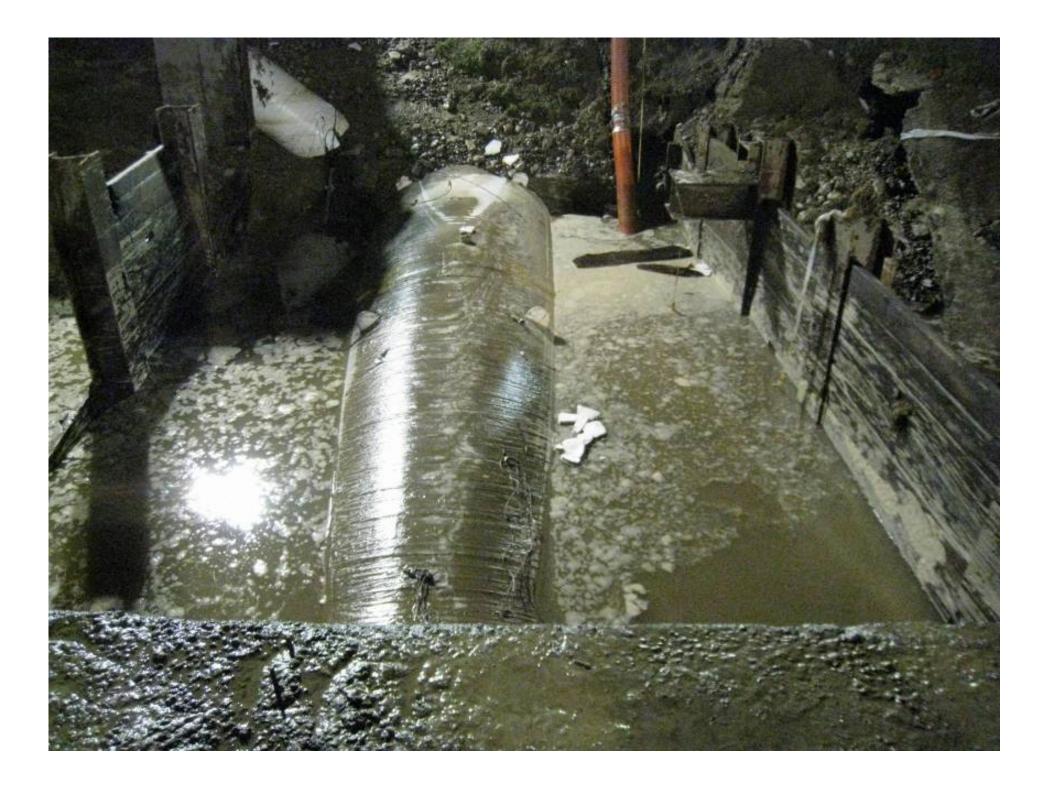
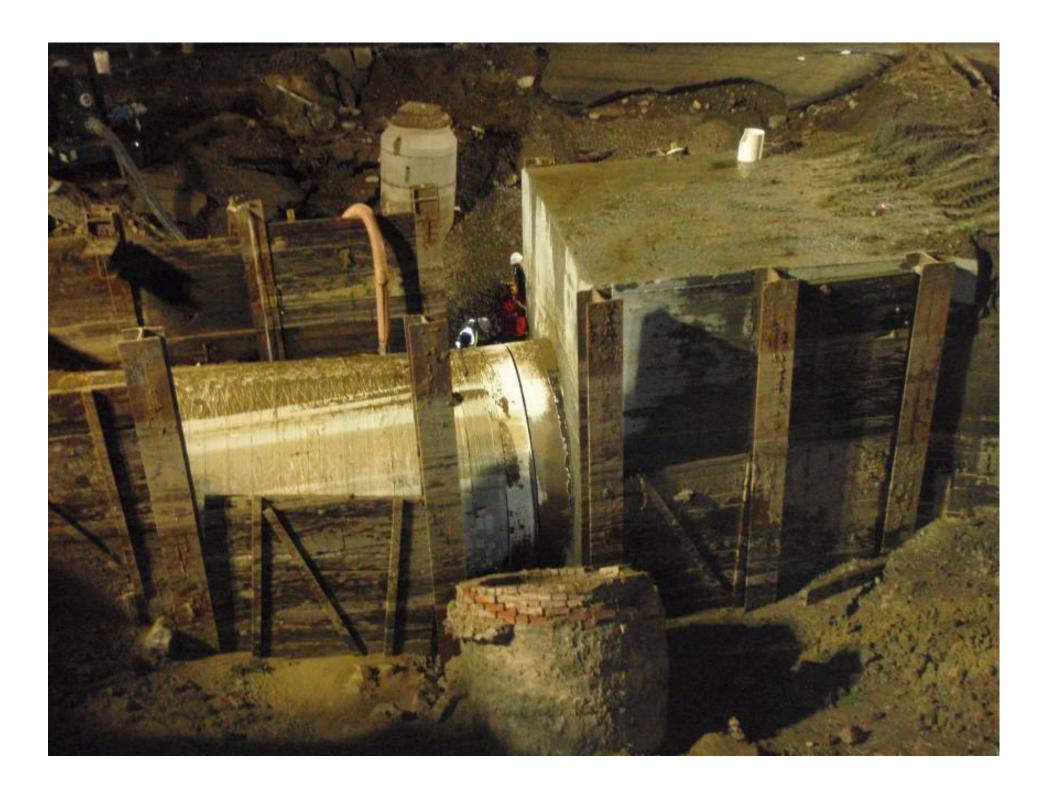
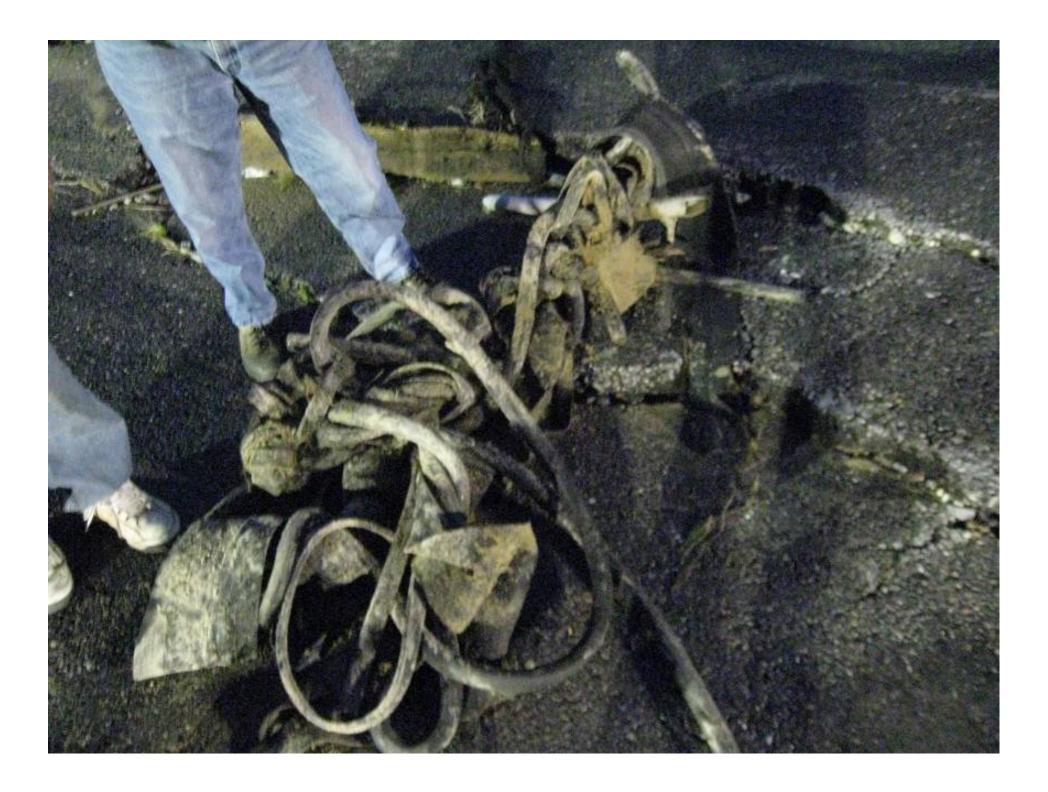
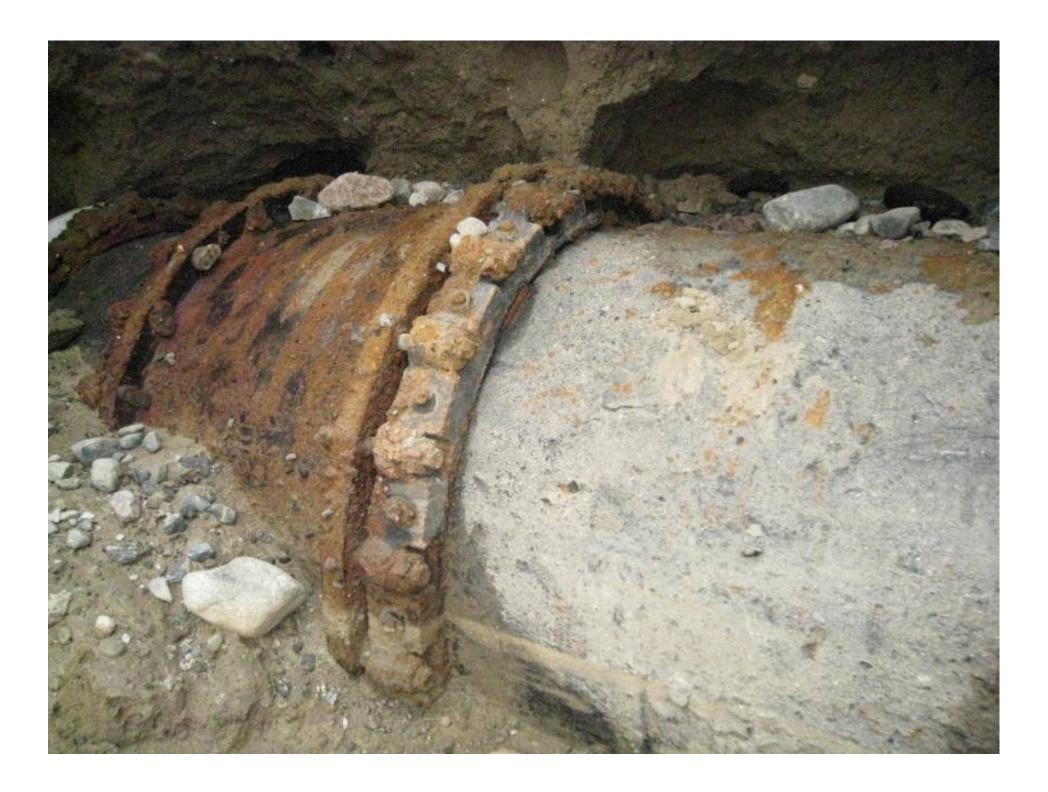
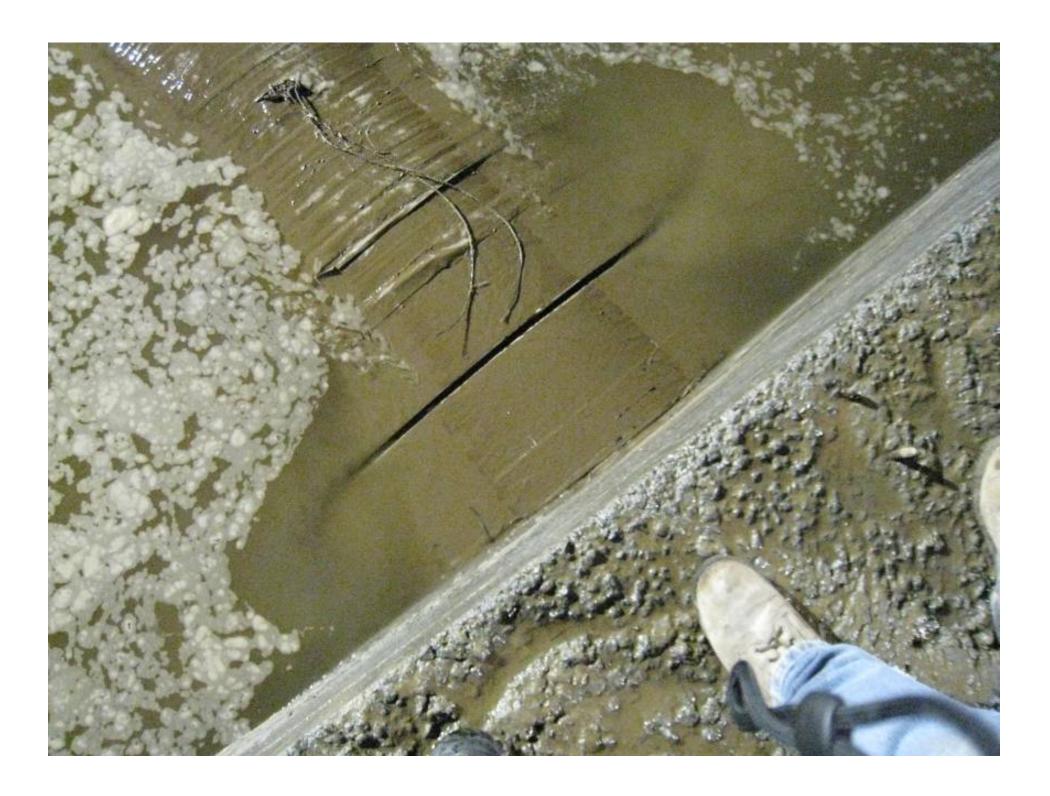
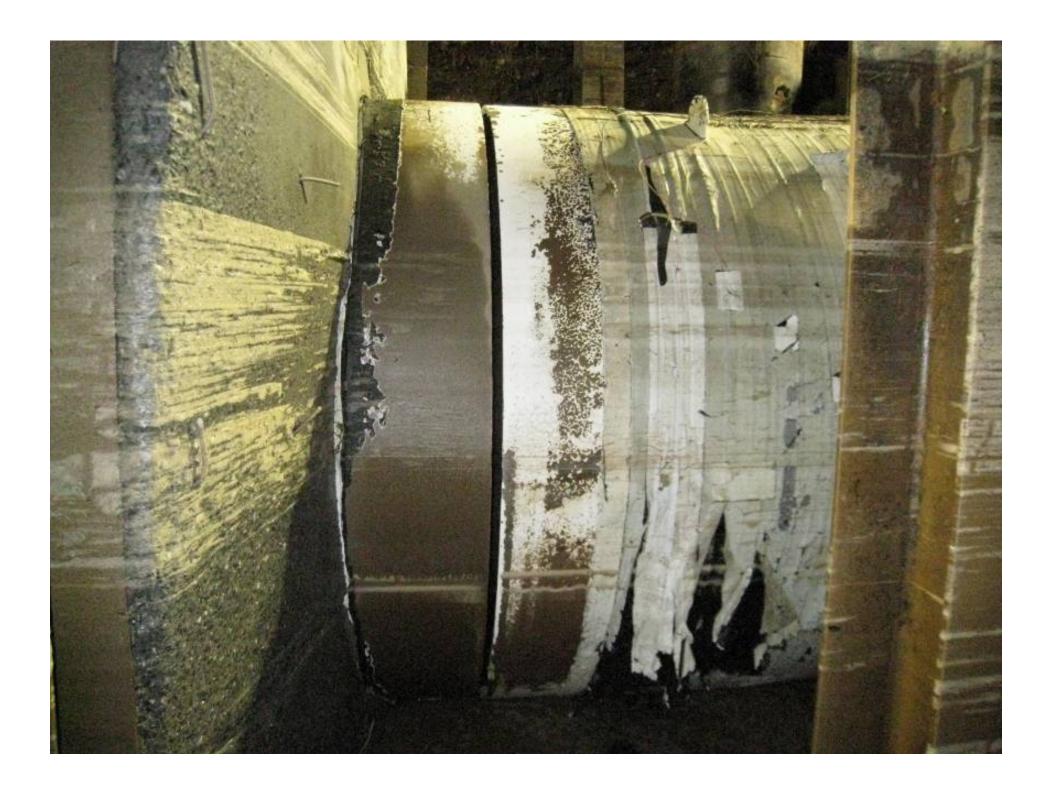
#### **Forensics to Date and On Going**

- As soon as the site (hole) was dewatered, MWRA Staff and Consultants and Contractor started:
  - Visual Inspection
  - Excavation below Pipe
    - People under pipe doing inspection
    - Vactor removal of loose material under pipe
    - Probing into soil under pipe by geotechnical consultant
  - State Police divers in Charles River looking for old collar
  - Ground penetrating radar and electromagnetic detectors to try locate old collar
  - Soil removal from River, with stockpiling on adjacent land to inspect for old collar or other information
  - Magnetic Metal Detectors
  - Metallurgical tests on any metal found
